'The coldest case of all' – fire investigation at the Viking Age ring fortress of Borgring, Denmark

Eva Ljungkvist¹, Benny Thomsen¹, Søren Michael Sindbæk^{2,4}, Jonas Christensen³, Nanna Holm³, Maja Kildetoft Schultz³, Jens Ulriksen³

ABSTRACT

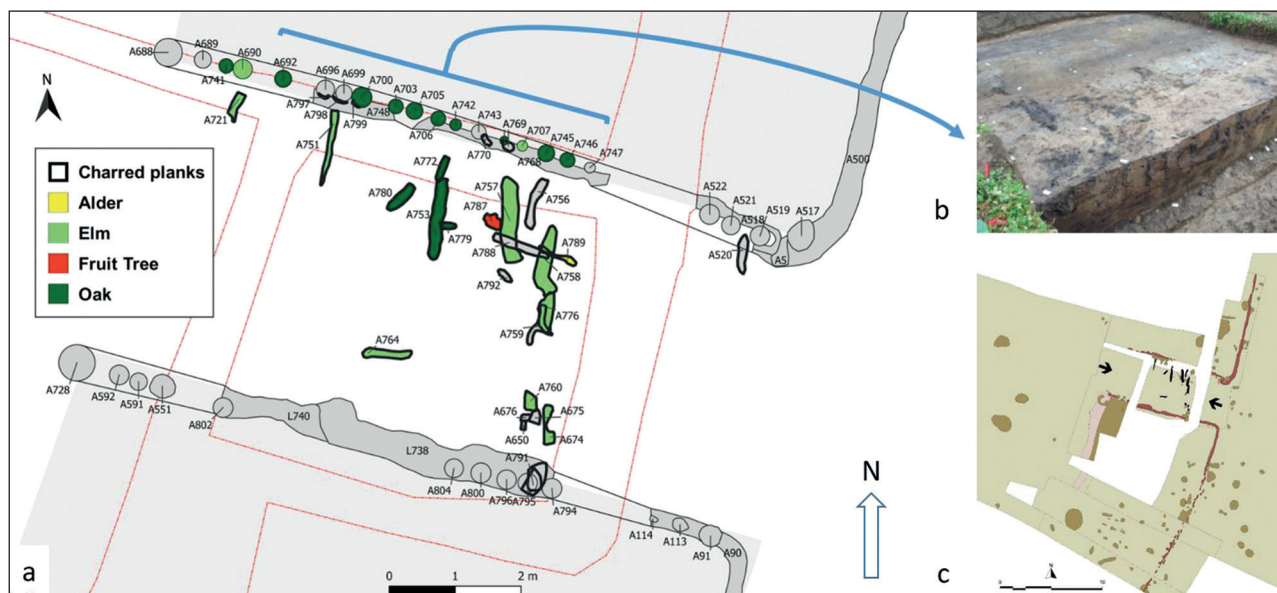
Figure 2. The east gateway with traces of standing posts in the sides and charred planks that has fallen into the doorway after fire. a) plan showing identified wooden structures; b) photo looking southeast; c) overview (Plans and photo: Museum Southeast Denmark).

The excavation showed that a part of the gateway had been exposed to fire. Charred timber planks could be seen in layers inside the gateway, and the posts in the northern side of the gate were charred towards the side facing the gateway. There was no corresponding charcoal trail on the southern side.

No traces of fire were found to affect the outer wooden cladding of the rampart or the outermost post of the gateway (feature A517, cf. Figure 2). From the second post (A519) and further into the gateway, large amounts of charcoal were seen in and around the remains of the posts, together with heat-induced reddening of the clay (Figure 4). The sides of the posts facing the gateway were charred halfway around, while the sides facing the rampart were untouched by fire. A c.1 m-long stretch of the central part of the north wall had been affected in another way. Here, minor posts both standing and lying down had been charred all the way around, indicating that the air had been able to circulate on both sides of the wall.

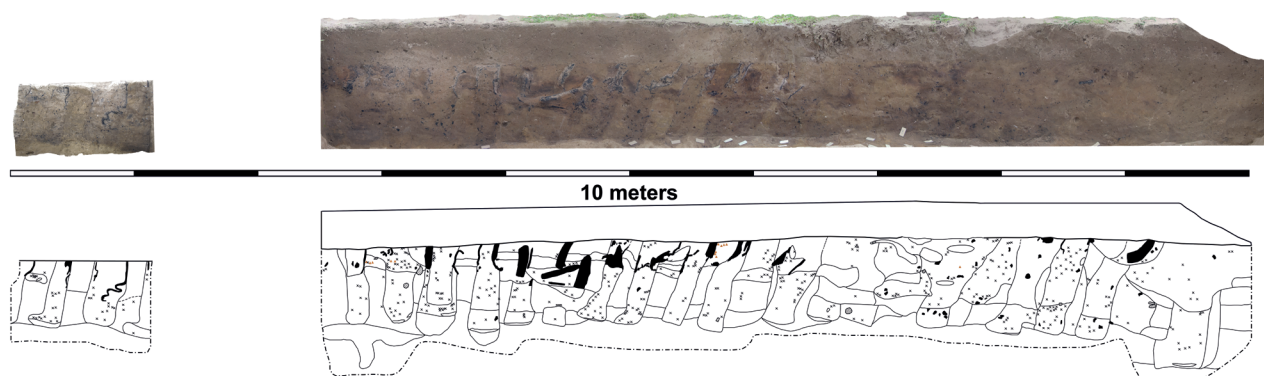
Figure 3. Section 51 along the northern side of the east gateway, looking south. Cuttings are marked in thin outline, charred wood in solid black (Drawings and photo: Museum Southeast Denmark).

pits dug 35-65 cm into the ground. The relationship between posts and rampart fill was investigated in several places, including section 51 (Figure 3). Here the turfs of soil are seen to touch the posts in both the northern and southern side of the gateways.

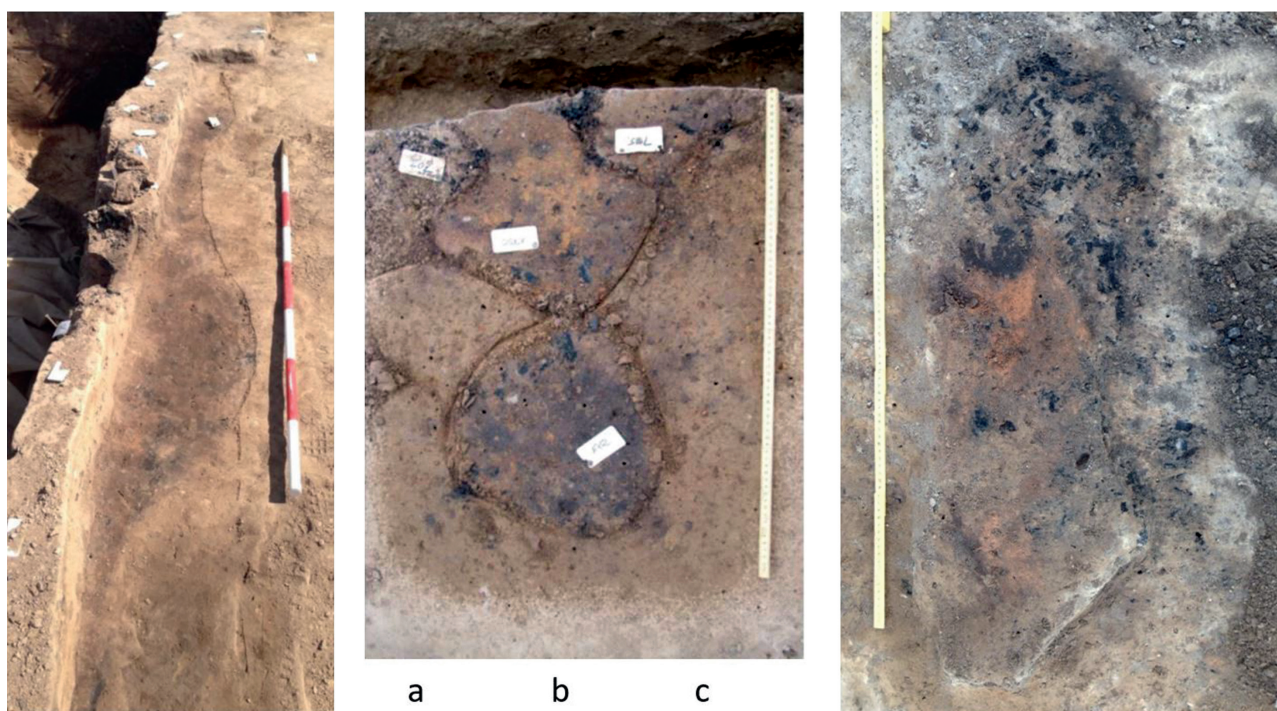
Figure 4. a) Strong red coloration formed by heat around the posts A697 and A699 (looking east) and b) posts A703 and A705 (looking north); c) Remains of a fireplace found approximately in the middle of the gateway, and used subsequent to the main fire event (Photos: Museum Southeast Denmark).

As excavation continued, a layer of soil strongly mixed with charcoal was uncovered, in which the clay was reddened by fire. Around the posts A697 and A699, *c.* 6.5 m inside the gateway as measured from the outer face of the rampart, a strong red coloration was seen in the fill layers. A similar coloration was seen around the posts A809 and A747, just 3 m from the front of the gateway. Apparently, only the northern side of the gateway had burned. On the southern side there were charcoal pieces in the ground, but no charred, standing timbers were detected.

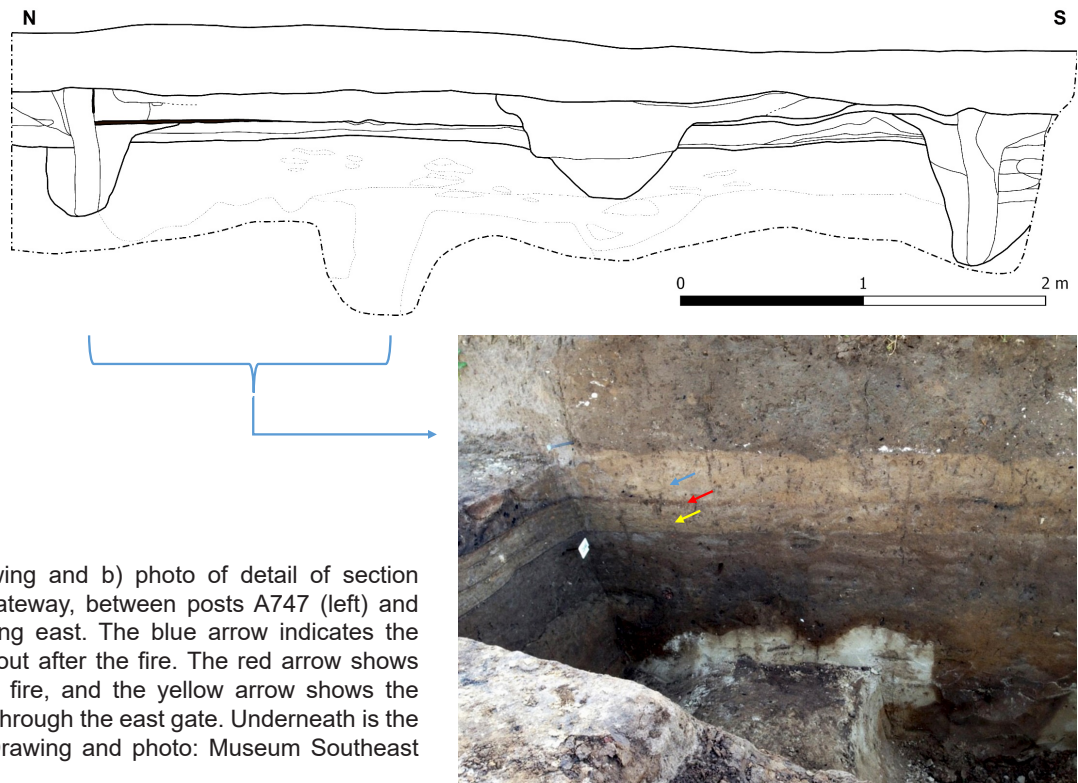
Figure 5. a) drawing and b) photo of detail of section across the east gateway, between posts A747 (left) and A794 (right), looking east. The blue arrow indicates the clay layer spread out after the fire. The red arrow shows the horizon of the fire, and the yellow arrow shows the original roadways through the east gate. Underneath is the original surface (Drawing and photo: Museum Southeast Denmark).

The stratigraphy inside the gateway is documented by a cross section *c.* 2 m from the front of the gate (Figure 5). In the top of the fill were visible remains of charred wood pieces, which were mostly oriented across the gate. These pieces of wood had the size and character of planks with widths ranging between 12 and 25 cm. Under the charred

planks was a compact layer of clay. In the northern part of the gateway, this layer was found to reach to the charred posts, yet without being affected by heat. A fireplace was found approximately in the middle of the gateway, showing a hard-burned red mantle formed in the clay.

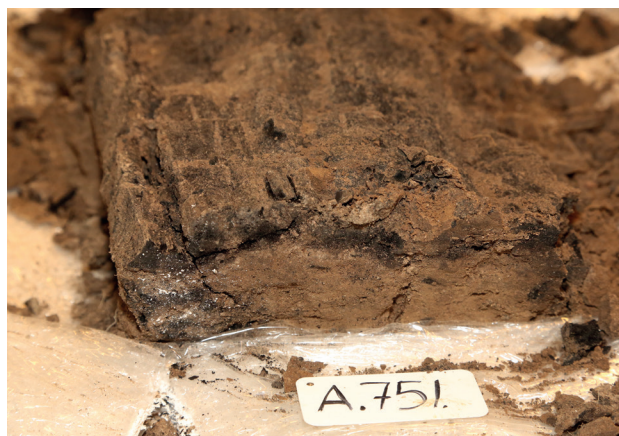
Considering the charred timbers from the east gateway of Borgring, detailed investigations of samples have demonstrated that they had a uniform appearance: the examined pieces had a charred crust of 2-4 cm and the cross section appeared with a curvature (Figure 7). After the fire, they seem to have been untouched until the fortress was abandoned. Eventually, the inside of the timbers rotted away and was replaced by soil.

Figure 7. Detailed investigation of charred timbers from the east gate of Borgring. The examined pieces had a charred crust of 2-4 cm and the cross section appeared with a curvature (Photo: NKC).

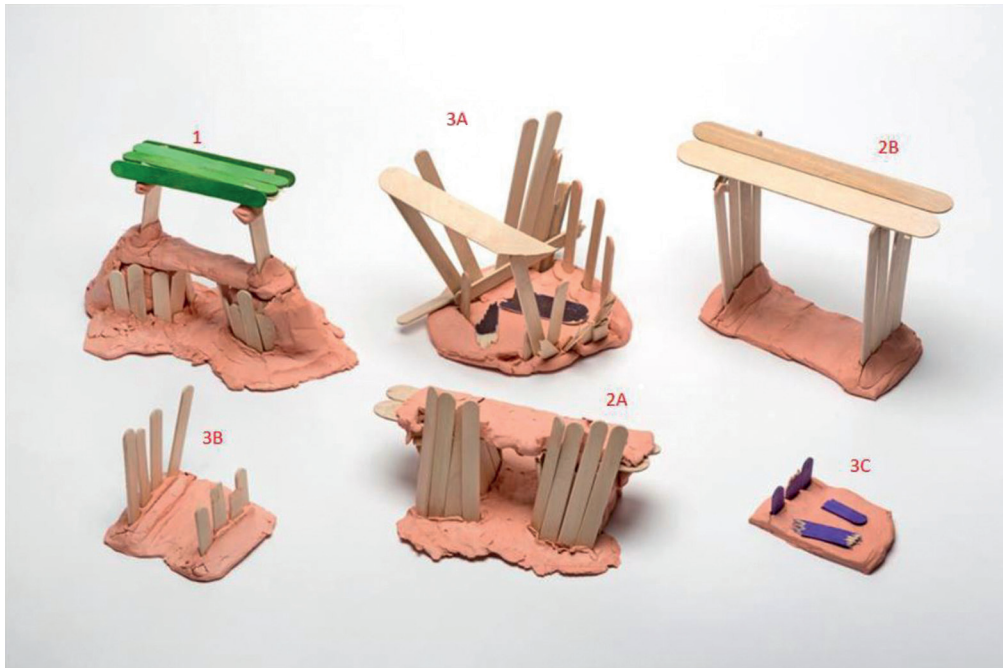
Figure 8. Models of the east gate in different stages: 1: Fully finished construction. 2A: Almost finished construction with roof and with soil cover. 2B: Almost finished construction with roof, but without soil over. 3A: Partial ruin with roof over some places. 3B: Partial ruin without roof. 3C: Ruin (Models: Eva Ljungkvist NKC. Photo: Johnny Thomsen NKC).

Our analysis does not yield a definite conclusion, but it indicates that the construction was neither built as in the Swedish Trelleborg reconstruction, nor was it in a state of a ruin. This implies that the construction was at least partially finished. It is considered most likely that the construction was wholly or partially finished with roof cover. That leaves the construction alternatives 2A, 2B, and 3A, and it is considered that the construction is more likely to be a combination or alternative of 2A and 2B, and not 3A.

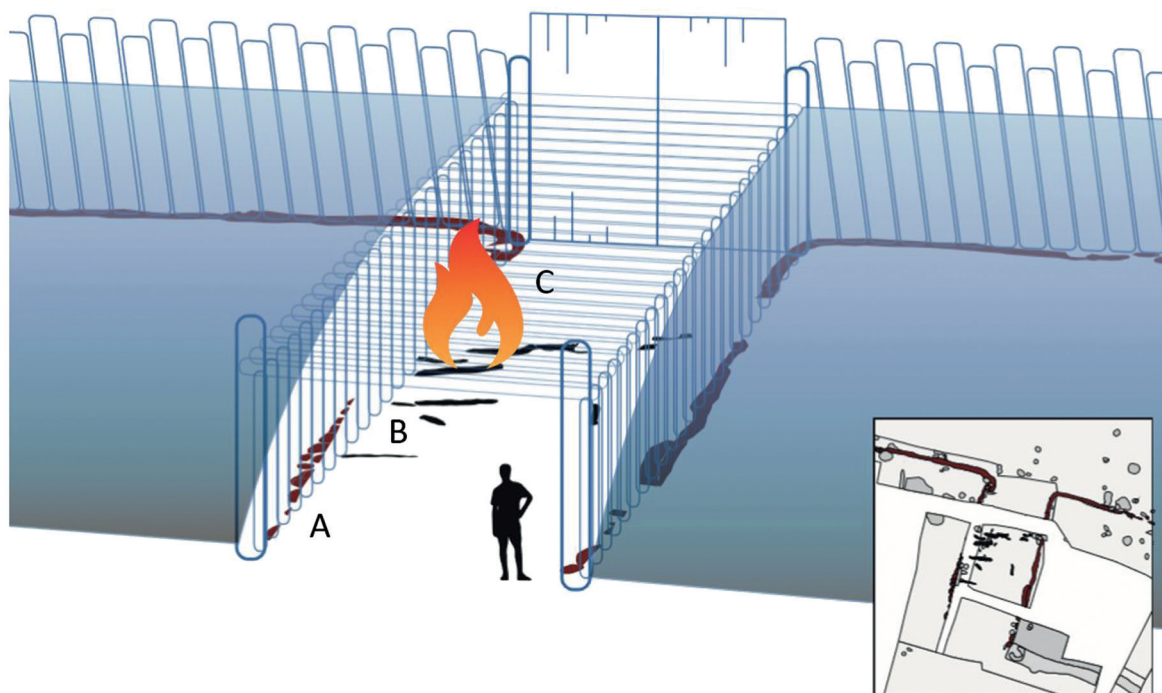
In the initial assessment, during excavations, the gateway was assumed to be a massive construction with dense wooden walls, as seen, for example, in the reconstructed Swedish fortress (Figure 6). However, the fire investigation reveal that the gateway was built as a light construction of undressed posts with a simple plank roof. It is even possible that the structure was in a partially unfinished state when a fire struck and ravaged the north wall and probably the roof cover or parts of it.

There is no conclusion as to where the fire began, though there are no traces of burning on the four corner posts or the timber clad front of the rampart. Neither is there evidence of fire inside the ring fortress. Considering the intensity and the duration of the fire too many factors are impossible to assess and therefore these questions are unanswered.

Figure 9. Visualisation of interpretation. The situation in area A is uncertain. Posts in B are burned all way round and leaning. Area C has vertical posts, which are not damaged by fire on the side facing the rampart (Drawing: Ea Rasmussen).
