Geomorphological effects of the Rømø Dam: development of a tidal channel and collapse of a dike

Margot Jespersen and Erik Rasmussen

Jespersen, Margot and Rasmussen, Erik: Geomorphological effects of the Rømø Dam: development of a tidal channel and collapse of a dike. *Geografisk Tidsskrift* 84: 17-24. Copenhagen, January 1984.

The Rømø Dam has had positive, but also negative effects on the surrounding wadden sea area. This paper describes the negative influence of the dam on the east coast of Rømø. Registrations have been carried out since 1951.

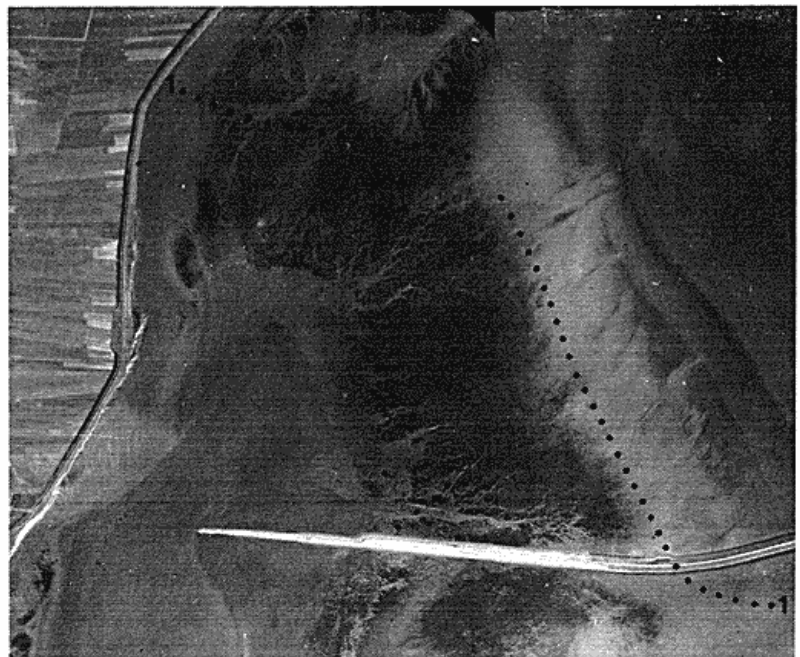
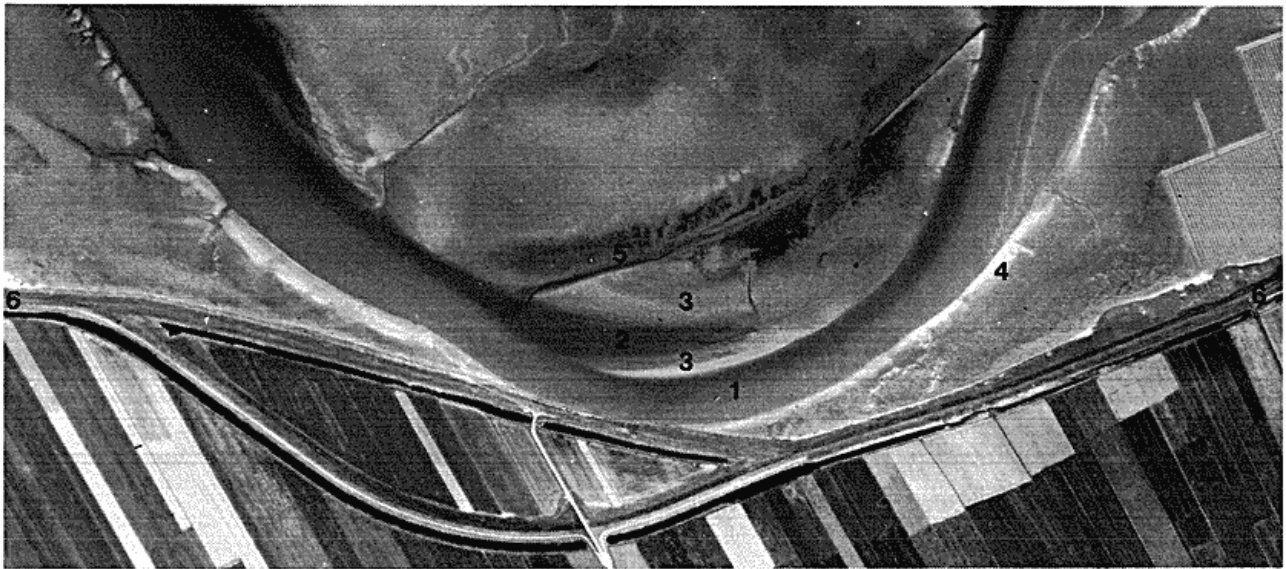
Fig. 3. Aerial photo from 1973 of part of the Juvre Priel. 1. ebb channel. 2. flood channel. 3. flood bar. 4. levees. 5. tidal creek. 6-6. Juvre Dike. Approximate scale 1:12 500.

In the Juvre Priel area the following characteristic tidal elements can be observed: ebb- and flood channels, flood bars, levees, and tidal creeks (Fig. 3). The ebb channel is the principal channel – mainly shaped by the ebb current – most often having distinct meandering tendencies. A flood channel is a blind tributary channel – mainly shaped by the flood current – short and almost rectilinear. In connection with flood channels, flood bars emerge consisting mainly of material transported by the flood current. The flood bar is crescent- or horseshoe-shaped (Børge Jakobsen, 1962). Levees mainly occur along the concave side of the meander curves of ebb channels and

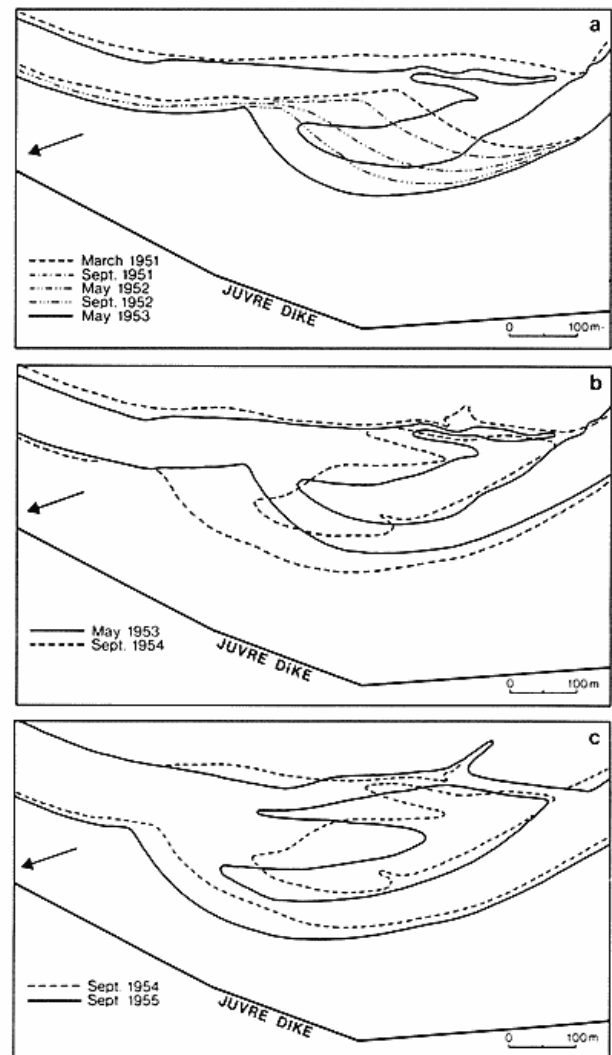
Fig. 4. The development of ebb channel, flood channel and flood bar in the Juvre Priel 1951-55. The tidal elements are shown by low-water lines.

The mapping of 1951 shows that the Juvre Priel was a neutral channel without separate flood- and ebb channels, but with a distinct meandering tendency. Fig. 4a shows the development of a section of a meander curve from 1951 to 1953, and it is seen that the concave side was rapidly migrating landward simultaneously with a displacement of the curve in a northern direction. In the course of one year, from March 1951 to May 1952 the meander curve eroded away a total wadden area of 2.2 ha, hereof the 0.9 ha from March to September and the 1.3 ha from September to May. The following year the total loss was 2.3 ha, hereof 0.9 ha eroded away from May to September 1952, and 1.4 ha from September 1952 to May 1953. The monthly average erosion was for the two summer periods 0.18 ha and for the two winter periods 0.17 ha. This means that the erosion was just as heavy in summertime as in wintertime. The decisive factor is wind action and water-level. The erosion is greatest during strong, easterly winds, since winds from the east cause extreme low-tides and consequently a strong ebb current which, in conjunction with wave action, has a vigorously eroding effect on the east-facing western wadden bank. It can be mentioned that, during a southeastern gale, a landward displacement of 3.5 m was observed of the western bank over a period of 48 hours. During strong and frequent westerly winds the erosion capability of the Juvre Priel is greatly diminished, because the high water-levels, generally remaining above wadden level, reduce wave erosion in the banks; moreover, they induce only relatively weak currents due to the fact that for the greatest part of the tidal period the water movements are not forced to follow the channels, but flow freely all over the area.

The mapping from 1953 shows that the Juvre Priel was no longer a neutral channel, as a flood bar was emerging in the area eroded away mainly by the ebb current. The flood bar had not yet reached horseshoe shape, but was markedly asymmetrical with a weakly developed easternmost branch. The following year, from 1953 to 1954, the northward displacement of the meander curve was continuing (Fig. 4 b). For this period, the eroded area totals 2.7 ha, the western bank of the meander being only 130 m from the dike in 1954 against 180 m in 1953. The flood bar had grown by almost 50%, but was still asymmetrical.

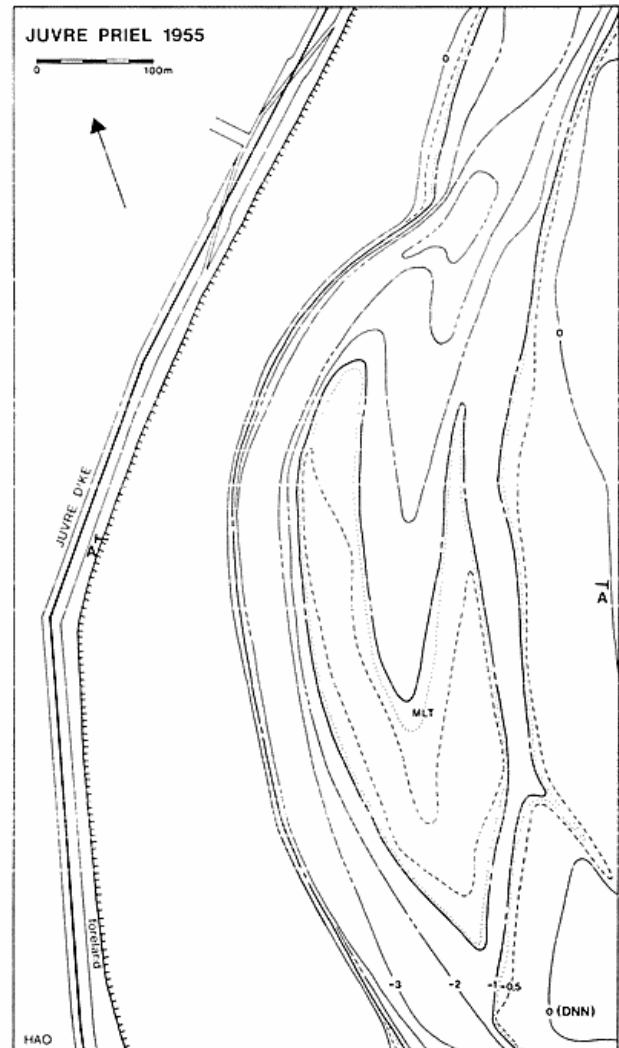
Fig. 5. Contour map from 1955. MLT: mean low-water line.
Fig. 5. Højdekont fra 1955. MLT: middellavvandslinie.

The area of the westernmost branch of the flood bar was both for 1953 and for 1954 roughly 5 times greater than the easternmost branch. From 1954 to 1955 the erosion by the meander was much less than the foregoing year, with a loss of area of only 1.7 ha. By now, the meander curve was being displaced toward the northwest instead of toward the north, and the western bank of the meander had now moved an additional 40 m towards the dike, so that, in 1955, the distance had been reduced to 90 m (Fig. 4c). The flood bar was now approaching the symmetrical horseshoe shape, the western branch being only 1.5 times the size of the eastern one. Between the two branches a well developed flood channel could be observed. The flood bar was clearly separated from the wadden east of it by a 20-40 m broad channel. The eastern border of this channel corresponds to the original eastern bank of the Juvre Priel.

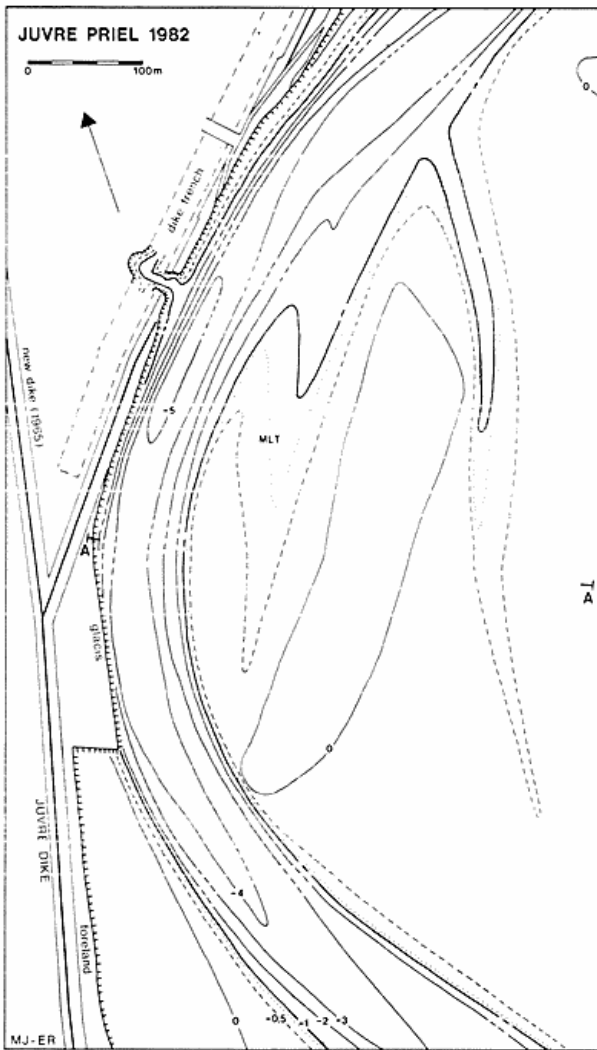
The development from 1955 to 1982 is shown on the contour maps, Figs 5-8. At the beginning of the period, from 1955 to 1958, the migration speed of the meander curve was decreasing; the total loss in area was only 2.8 ha, or approximately 0.9 ha per year. In 1958, the western bank of the ebb channel was located roughly 50 m from the dike; this means the same displacement in three years as previously in one year. The direction of migration was still northwesterly, i.e. almost at right angles to the dike. In the following years the landward migration of the meander continued. By 1963, the ebb channel had eroded its way up to the foreland, by 1967 up to the base of the dike, and in 1974 it had reached the core of the dike. From 1958 to 1974 the total loss of area amounted to 5.2 ha. For the periods 1958-63, 1963-67, and 1967-74 the average annual losses have been calculated to be 0.5 ha, 0.3 ha, and 0.2 ha respectively. This clearly shows that the

landward migration speed was still decreasing. The trend continued for the period 1974-82, when the average annual loss in area is less than 0.2 ha. Along with the decrease in migration speed of the meander curve, the ebb channel was deepened. In the part of the ebb channel shown in Figs 5-8 the total area with depths greater than -4 m DNN had increased by 2 ha from 1955 to 1982. In 1982 even an area with depths greater than -5 m DNN was observed.

Fig. 8. Contour map from 1982.
Fig. 8. Højedkort fra 1982.

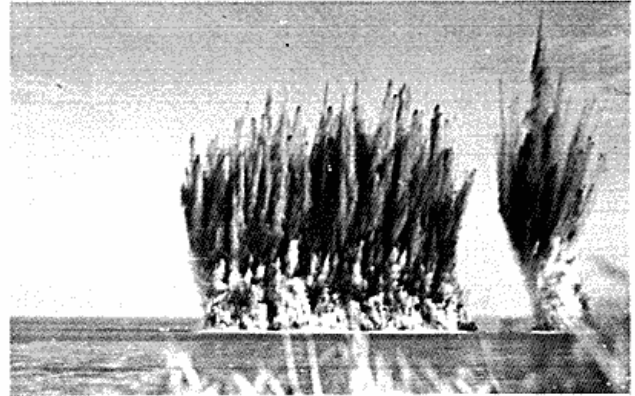
As early as in 1951 it was realized that the erosion by the Juvre Priel might damage the Juvre Dike on the eastern coast of Rømø. An attempt was made to establish a new outlet from the Juvre Priel basin (Fig. 10) by digging a canal from the western part of the Sælpriel to the basin, unfortunately with no success. So, in 1959, a canal was blasted instead. At the same time a canal was blasted through the flood bar of the Juvre Priel (Fig. 11). Neither did these measures give a lasting result, the blasted canals very rapidly filled up with sand. The main reason is that both these areas are dominated by the bar formations of the flood current. In 1966 a relief canal was dug on the wadden east of the flood bar in order to establish a connection between the Juvre Priel basin and the northern part of the ebb channel. To the west, the canal was supported by a brushwood groyne, part of which can be seen in Fig. 3, and, to improve its function, artificial seaweed was spread out over 1500 m² south of the flood bar. It proved impossible, however, to force the ebb current of the Juvre Priel through the relief canal which is today completely blocked by sanding up. Together with the attempts to establish new drainage possibilities from the Juvre Priel basin, it was tried to decrease the volume of the basin by land reclamation. The first sedimentation basins were established in 1958, and have since been maintained and even extended. The effect of them has hitherto been limited, however, as they only comprise a minor part of the basin.

Fig. 11. The blasting in 1959 of a canal through the flood bar.
 Fig. 11. Sprængning af rende gennem flodbanke i 1959. (Foto: M. Jespersen).

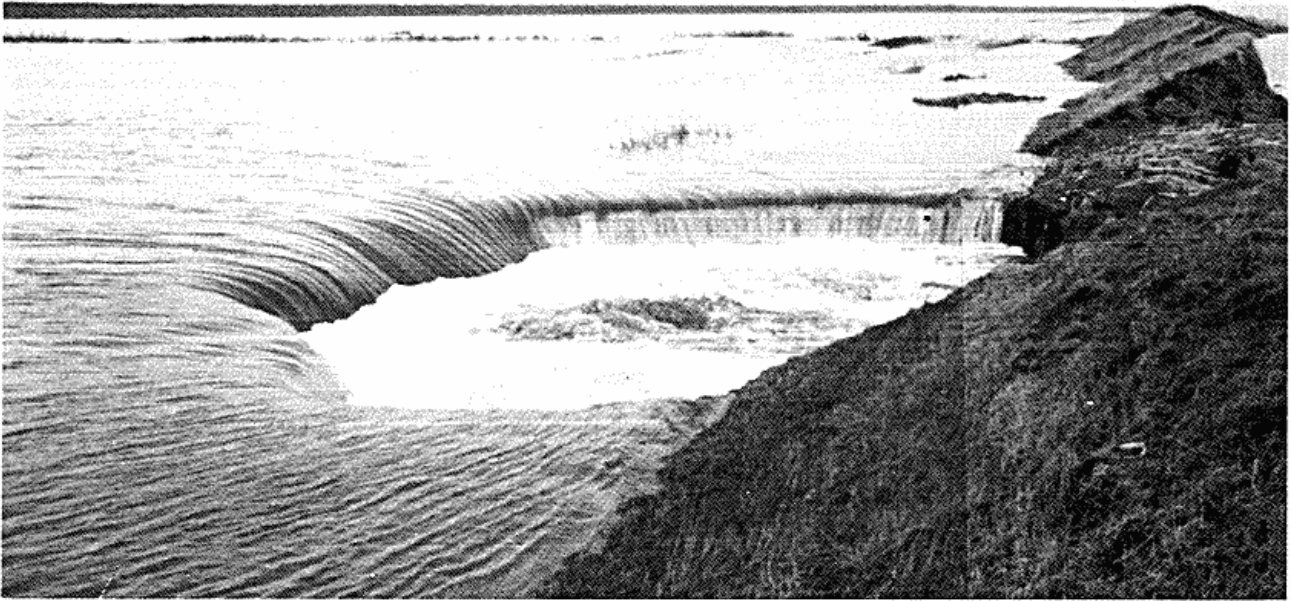
Fig. 12. The area between the old and the new Juvre Dike after the storm surge in 1981. The trapped water has breached through the dike and flows out into the Juvre Priel forming a cascade.

breaching the dike from the inside. How this breach happened was observed by the late Lehman Petersen, Rømø, who gave an account hereof to the authors, which is outlined below:

On Friday the 27th of November 1981, the low-tide in the Juvre Priel was about 9 a.m. At 10.10 it was observed that water was overflowing the dike in a 1-cm thick layer in two places, each 1-2 m long. Furthermore, a weak seeping could be observed about 1 m under the surface of the foreland. At 10.30 two longitudinal cracks appeared in the dike. The distance between the parallel cracks was about 30 cm. East and west of them, marsh clay was found, and between the cracks there was sand. About 1.5 m below the surface of the foreland, there was a hole with a diameter of about 10 cm. From this hole, clear water gushed forth as from a spring. At 10.40 the sand between the cracks had sunk about 2 cm, and the water welling up from the hole was now alternately clear and muddy. Gradually, the sand subsided about 50 cm, while the clay on the sides remained. Then, the sand suddenly subsided about 75 cm and simultaneously a seepage occurred over a longer stretch at the level of the surface of the foreland. The hole further down had now become covered by the beginning flood in the Juvre Priel. So far, the water has overflowed both clay crests and the subsiding sand. After the sudden subsiding of the sand, the water crossed only the inner clay crest, and from there it percolated the sand and see-

ped out on the outer side of the dike. The outer clay crest, which had by now become dry, gradually collapsed due to undermining, cracked and fell out into the Juvre Priel in larger pieces. About noon the outer clay crest had disappeared, the last sand was washed away, and the overflowing water began to erode the eastern side of the inner clay crest, after which it too collapsed. From now on, the water ran unhindered through the dike, and the vigorous current rapidly eroded a deep channel into the foreland. Later measurements showed that this channel reached a depth of -1.5 m DNN. Inside the dike breach a cascade soon developed (Fig. 12), which, during the next hours, eroded its way into the marsh area on the western side of the dike trench, and there, shaped a regular, semi-circled hole (Fig. 13) with a radius of 10 m and maximum depth of -1.7 m DNN.

After the breach of the dike in 1981, several measures have been taken to secure the eastern coast of Rømø. In 1983 the remains of the destroyed dike were dug up, and the material was used to reinforce the recessed dike. Moreover, a 0.5 ha large wadden area south of the breach was filled up in 1982 (Fig. 8) and, towards the Juvre Priel, secured with a glacis of large blocks. The future investigations in the area will primarily focus upon the effect of this human interference on the morphological development of the ebb- and flood channels as well as flood bars of the Juvre Priel.

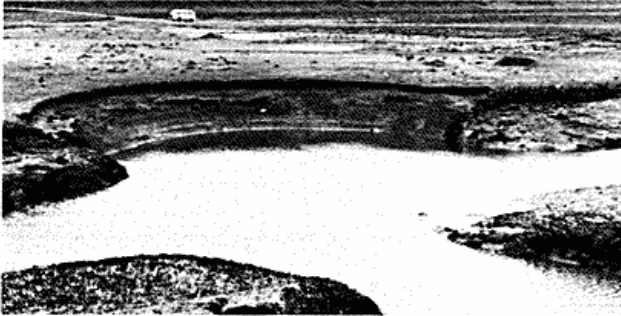
Fig. 13. Semicircular hole formed by headward erosion after the storm surge in 1981 (Fig. 12). On the former cultivated area between the two dikes (Fig. 3) a sparse vegetation of *Salicornia* is found.

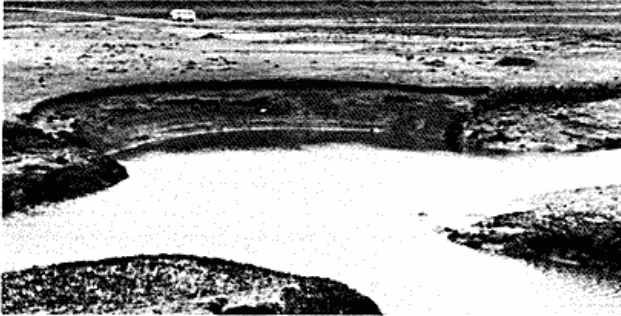
Fig. 13. Semicircular hole formed by headward erosion after the storm surge in 1981 (Fig. 12). On the former cultivated area between the two dikes (Fig. 3) a sparse vegetation of *Salicornia* is found.
