The Bishop of Ribe's rural property in Lustrup

Morten Søvsø*

– a magnate farm from the age of the Valdemars¹

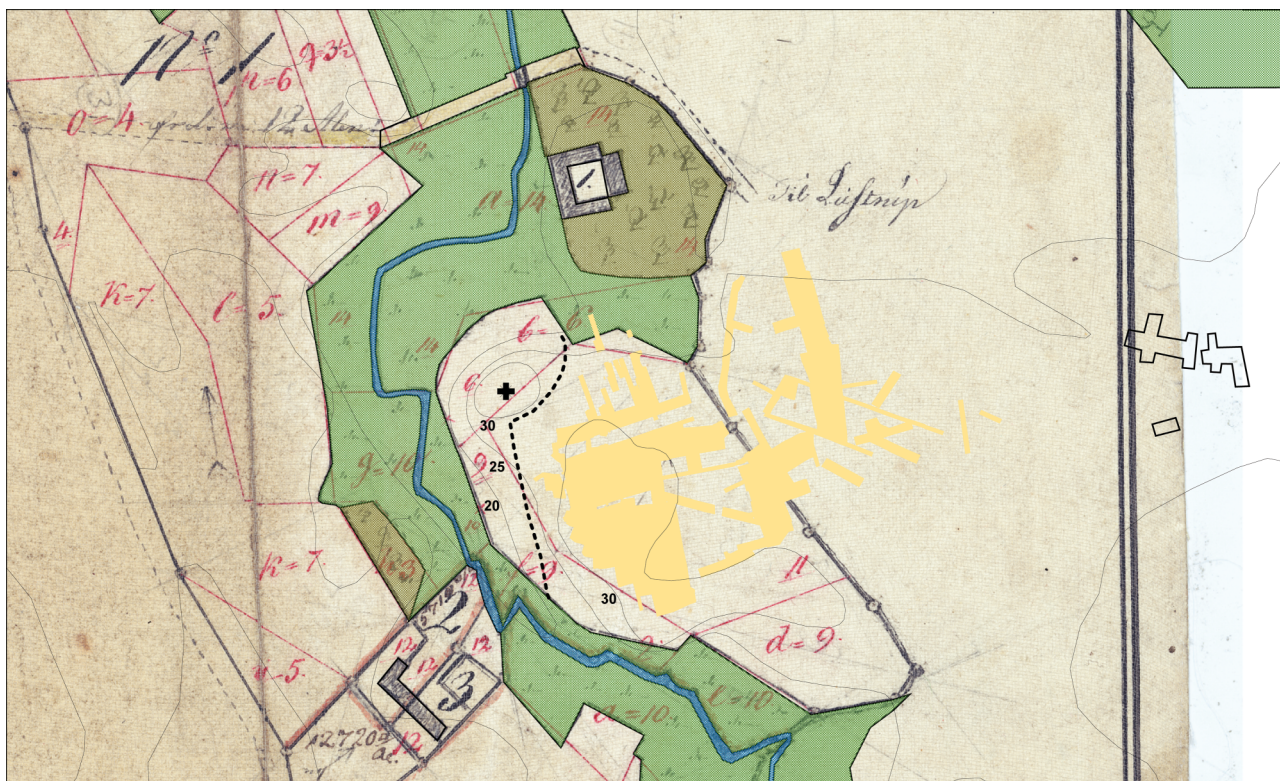
Figure 4. By combining the oldest preserved cadastral maps with the height contours from the Topographical Maps from surveys around 1850, one can reconstruct the earlier appearance of the landscape. As is evident, the northwestern part of the point was formerly a striking element, but the area west of the broken line has today been removed by sand-quarrying and a meadow irrigation system. On the point there was an artificial bank, known from a description in the 1860s. This may have been an earthen wall belonging to the northern farm. The placing of the excavation fields is marked in yellow. From the cadastral map of 1839 with additions by the author.

By studying the oldest preserved map of the area and earlier height contours, it is possible to reconstruct the appearance of the landscape around 1800. Although there may also have been changes earlier, it is far from unlikely that this picture of the landscape shows us a situation like the one when the buildings of the magnate farm occupied the site on the point at Lustrupholm (Figure 4, original landscape).

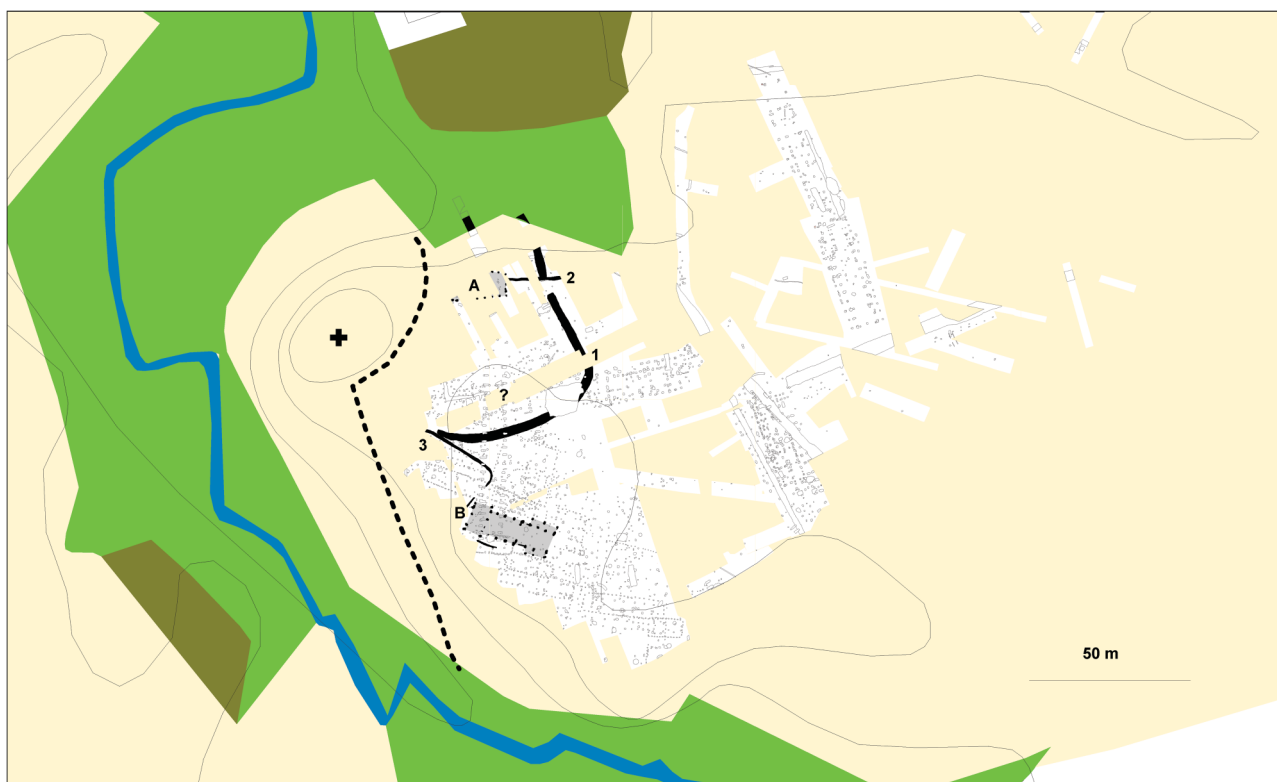
Figure 6. Phase 1. Buildings and ditches belonging to Phase 1 of the medieval settlement from the twelfth century. Building A has two circular post symbols against the background of an accurate sketch made during the digging of a pit-house at the Viking Centre market place in 1993.

Sand-quarrying and terrain regulations have transformed the area where Building A lay, so much so that the possibility of its existence was not realized until after the excavations in 2006. These were followed up by limited surface stripping in 2007, which was not made easier by the fact that the Viking Centre's market place uses the area at present. The western end of the building has been destroyed by sand-quarrying, and only the bottom centimetres of the post-holes of the south wall were preserved. However, this was enough to establish that there has been a building with curved long walls, whose width in the middle had exceeded 9 m. The building does not seem to have had projections; it consisted of two rows of roof-bearing wall post-holes. In these two post-holes were found; one of the rhenish Paffrath type and the other of local grey-fired ware. From the east gable a ditch started, Ditch 2, which is discussed below. Buildings with curved long walls consisting of just two rows of roof-bearing wall posts are well known in the archaeological material. They are known from Vorbasse and a number of other sites and are dated in general to the eleventh/twelfth centuries.

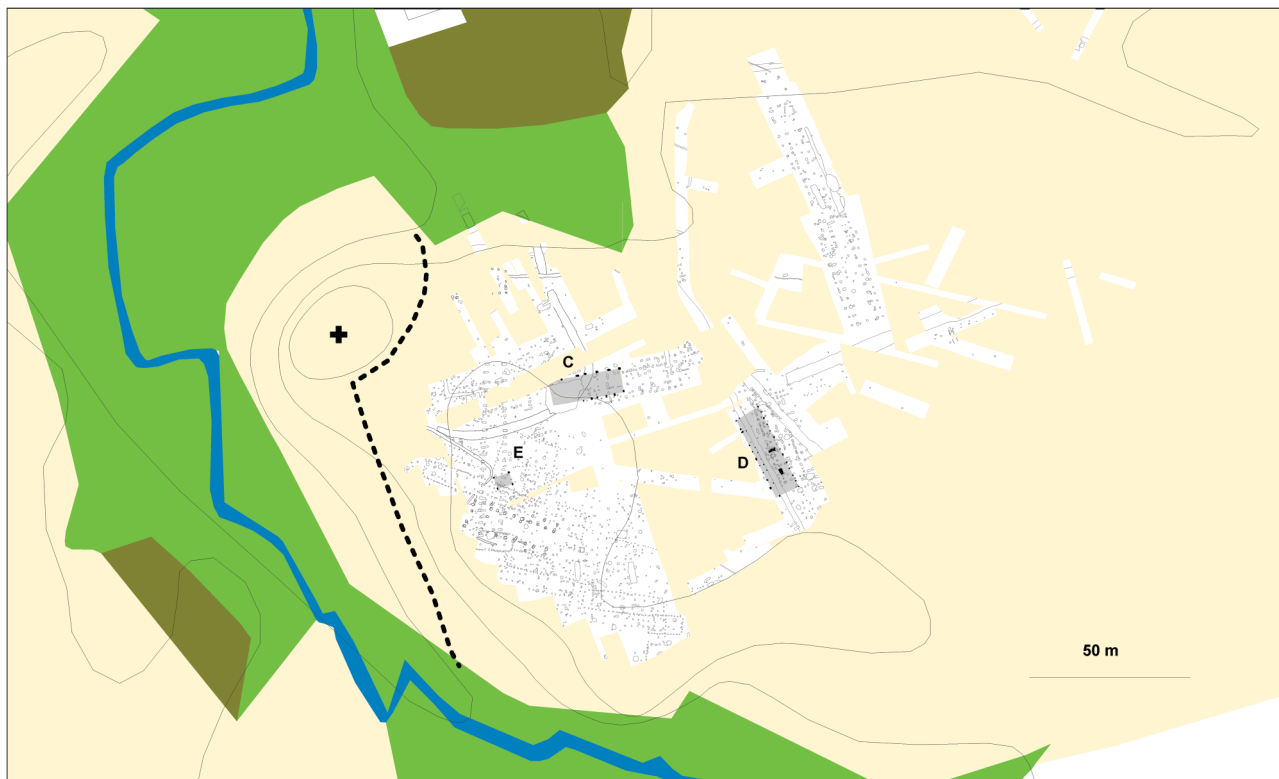
Figure 8. Phase 2. Appearance of the farm c. 1200. The complex consisted of two 8 m wide post-built houses and a probable four-post feature, Building E.

throughout the length of the building. The northern part of the west wall was excavated in the 1999 season, while the other parts of the building were identified and excavated in 2003. The full width of the building was 7.9 m, of which the projection took up 1.2 m. The length of the building was 27.6 m. No finds emerged from the post-holes.

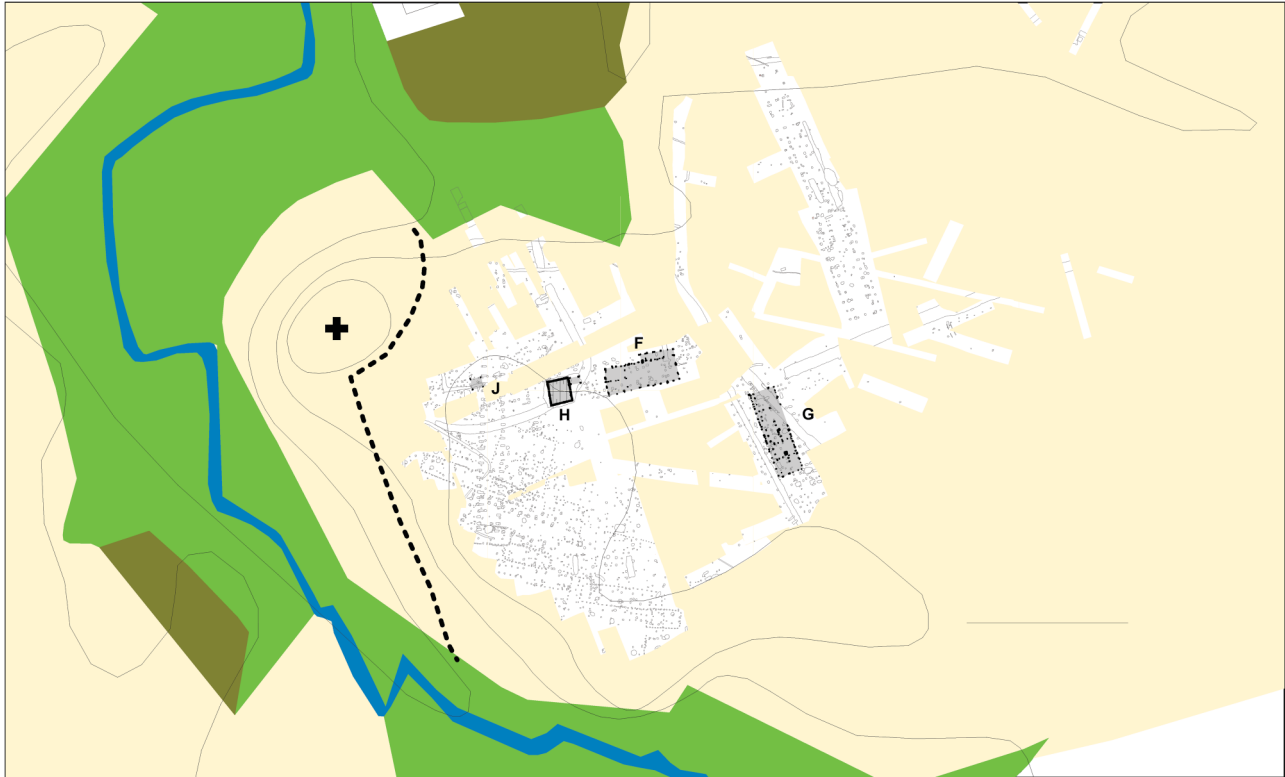
Figure 9. Phase 3. First quarter of the 1200s. The oldest set of buildings at the farm are replaced by two new ones, and the prestigious brick house with the wood-built stairwell is erected. To this phase a four-post feature probably also belongs.

In Phase 3, the two oldest buildings on the Bishop's property were rebuilt. Building C was succeeded by the equally wide Building F, displaced 18 m to the east. This may have been because the erection of the brick structure Building H was also planned at this time. Building D was also replaced by the apparently identical Building G, which partly overlaps the older site (Figure 9, Phase 3).

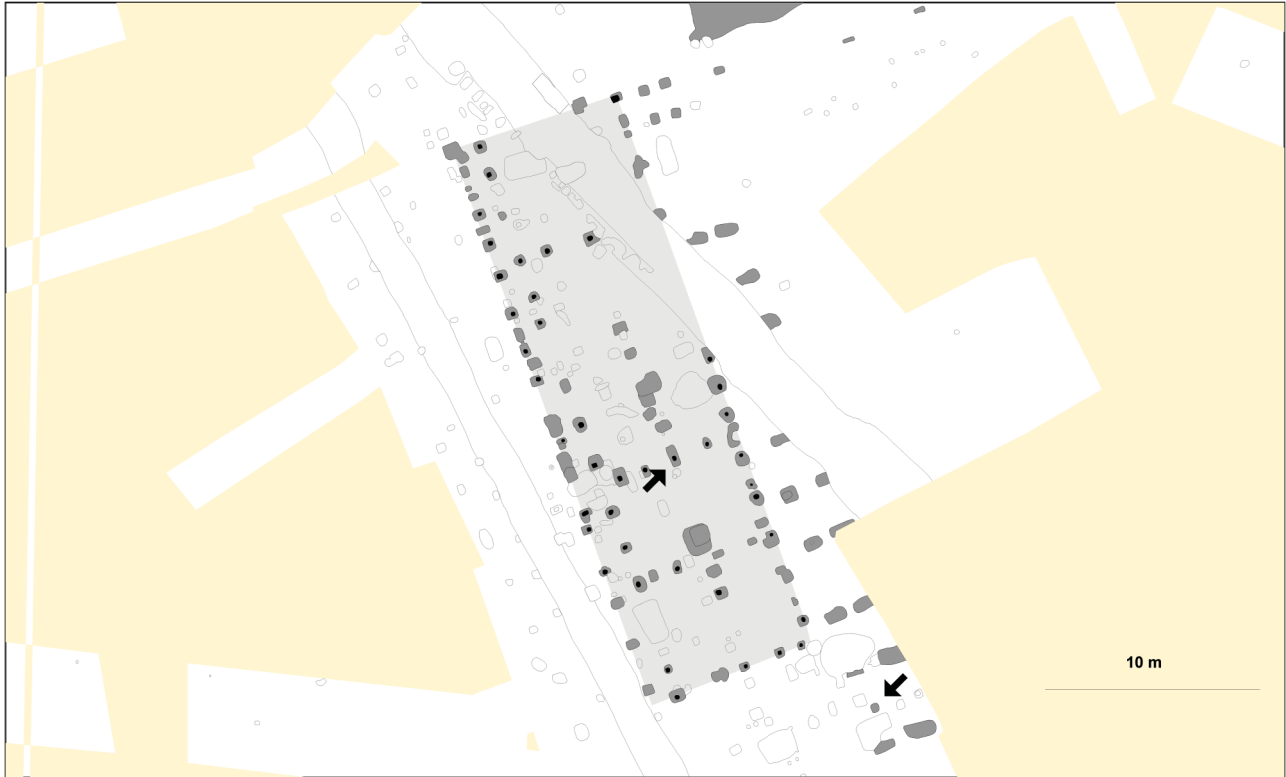
Figure 11. Thanks to very clear post traces (marked in black), the burnt-out Building G provided a precise “snapshot” of the positions of the posts in the building, which was divided into four rooms and had projections on the west side. Inside the house, as in its predecessor, a number of pits were found whose function is not known. On the eastern side of the house towards the north, one can see a four-post feature and towards the south the post-holes from the possible post-borne plank road. The arrow inside the house marks the position of a fireplace, while the arrow beneath the plank road marks the position of the pit with the crushed pottery and the coins.

Building G is a well-preserved NNW–SSE-oriented post-built building with projections on the west side along its whole length (Figure 11, Building G). It is the best preserved post-built house site of the excavations, partly because the building had burned down. Another reason for the good state of preservation was that most of the house site was located beneath the dike that formed the boundary between the property associations Lustrupholm and Lustrup. Prior to the establishment of the earth wall, there had been a phase when the area was ploughed, which was discernible over the fire place from clearly charcoal-filled plough traces in the original brownish-grey soil layer.

How the house was constructed above ground we cannot say with certainty. There is a tendency for wall posts to form pairs across the house, but it is not consistent, and it is equally important that the central partition wall of the house with its secondary stove was not located at a pair of posts. This suggests rather that the pairs of posts were not joined by transverse tie-beams but bore a longitudinal wall plate on which the roof construction,

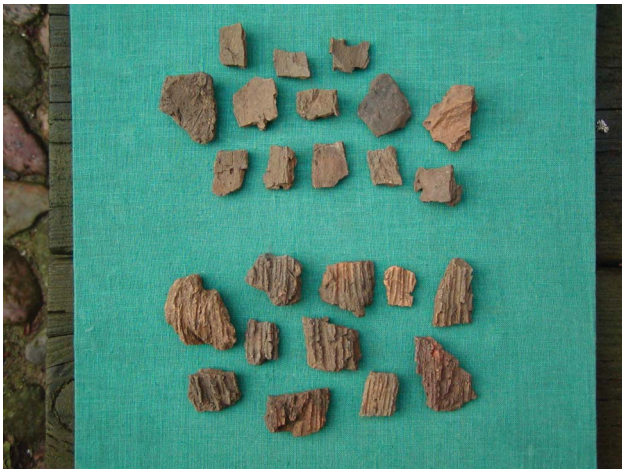
Figure 12. On the thousands of burnt mud-wall fragments from Building G impressions of straw are the only traces of what they had been applied to. In the panels such straw mats must have been mounted, but how they were attached to the wooden skeleton of the building we do not know. The actual clay layer is usually less than 1 cm thick.

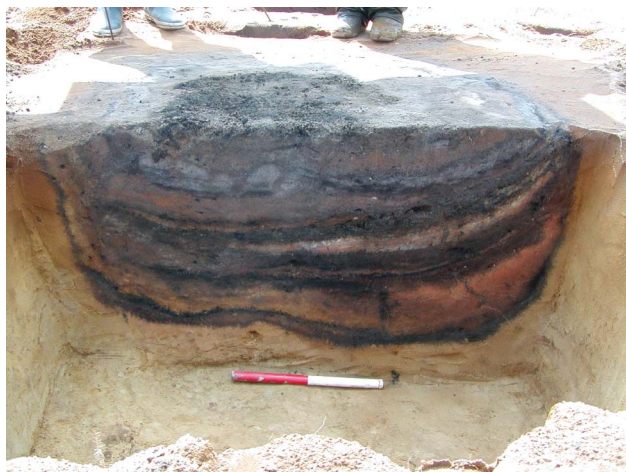
Figure 13. Section of the pit A345, which formed part of Building D. Originally the pit was filled with an organic layer that has wholly decomposed and now consists only of the brown streak at the bottom. In the process, the overlying floor layers, which belong to Building G, were pulled down under the plough layer and form the only preserved floor layer from Building G. There are traces of both a mortar floor and a layer of laid-out heath turf.

As in its predecessor, Building D, in Building G too there were a number of rectangular pits approximately in the middle of the building. Thanks to the pits in the preceding Building D, remains of Building G’s floors were preserved. This was so because the fill in the older set of pits had collapsed and had drawn the layer above down with it and beneath the depth of the plough (Figure 13, cross-section of pit with fine layering). The fill in the older set of pits was all sealed in by a fire layer with mud-wall material, and beneath this in all three pits remains of mortar flooring were found as well as laid-out layers of heath turf.

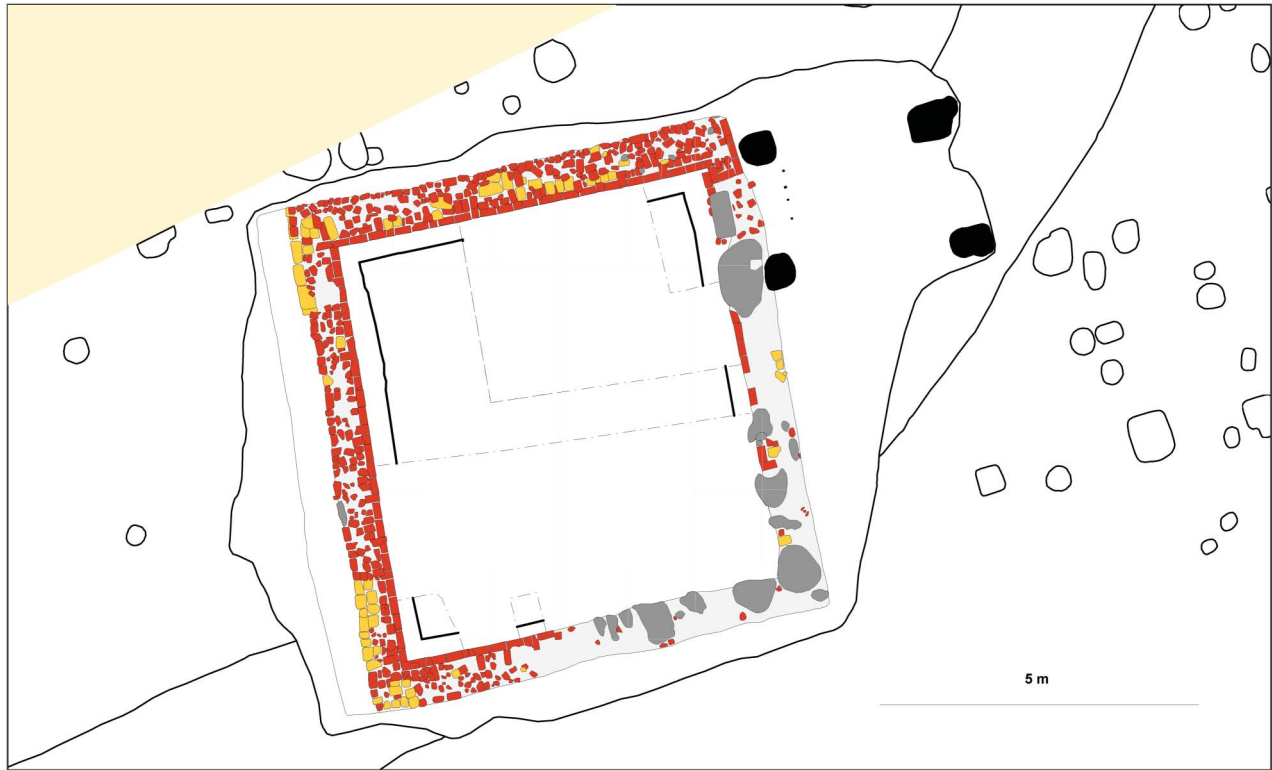
Figure 14. The registered wall remains from the cellar beneath Building H. Tuff stone is marked in brown, while fieldstones are grey. At the north end of the east wall, one can see remains of the bevelled door and the stone threshold. Outside this we see the four massive post-holes from the wood-built stairwell and, in a row, the four iron nails that were part of the wholly decomposed stairs down to the cellar. The investigated areas of the floor layers are marked, and a line marks the course of the oldest wall bench.

The original structure: The excavated wall remains form a cellar whose outside dimensions were 7.9 m N-S \times 7.4 m E-W. The walls stood on a foundation of fieldstones and were built of brick in monk bond set in shell-tempered mortar.²⁴ In terms of masonry technique,

At the northern end of the eastern wall the remains of a door opening were found. This was an outwardly bevelled opening whose width, measured in the outer alignment, had been 1.4 m. Inside, the opening was surrounded by half-brick filleting which at some later juncture had been cut way in the preserved north side of the door opening. In the sixth course of the cut-away filleting a now-decomposed piece of wood had been mounted, in which the lower of the door pintles had been mounted. It had thus been a left-hand door and opened into the room, as was also shown by the shape of the youngest wall bench. In the door opening a granite ashlar had been laid as a threshold stone. The first stage of the laying of the oldest Floor 1 had been a 10–12 cm thick layer of marine clay, which must have functioned as damp proofing, and over this a mortar floor just 1 cm thick was poured, which, probably thanks to the frost-free depth, had preserved its hardness. The mortar floor was 1.9 m beneath the surface at that time.

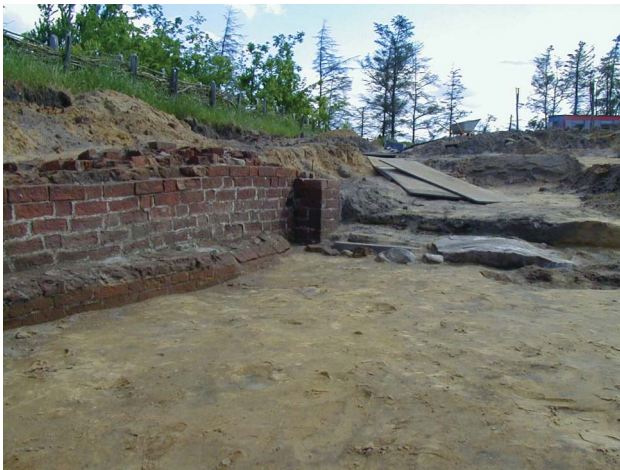
Figure 15. The northwestern corner of the cellar seen from the southwest. The door jamb and the younger wall bench can be seen. Where the door opened, the bricks are set diagonally, and the primary function of the wall bench was probably to conceal and seal in front of projecting foundation stones.

On this floor, round along all four walls, a one-brick wide wall bench was laid; at the door opening it functioned as the bottom step of the stairs into the room. The wall bench was later removed and was only evident from a few remains and the impression in the mortar floor. The construction ended with the pouring of a wearing course on the floor consisting of mortar tempered with crushed brick, making the floor appear in a warm red colour – almost like a tennis court. In the mortar on the floor gutters were made, a few centimetres wide and deep, which, judging from the excavated section, seem to have been N-S oriented. Perhaps they led to an unexcavated sump? On this floor a thin layer of dirt was found, but no finds emerged from the excavated parts of the layer.

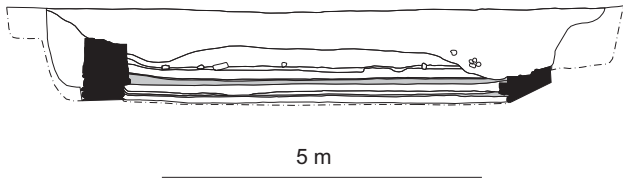
Figure 16. Section through the cellar ruin with floor and fill layer. The intact mortar floors, Floors 1 and 2 are marked in grey.

Later rebuildings: Before the laying of Floor 2 of the cellar, the wall benches along all four walls were removed. Then, first, an underlay of grey marine clay was laid, followed by a layer of crushed brick and mortar, and finally a layer of mortar which, like the oldest floor, had preserved its hard surface. On this floor, but only along the north wall, a one-brick wide, three-course high wall bench was built, which was fully preserved. Towards the east, where the door opened, the wall bench was built up of diagonally laid stretchers – probably so as not to be in the way of the door (Figure 15, wall bench behind the door). In the first layer on Floor 2 or the overlay a coin was found that had been minted in the reign of Valdemar II, and which was in circulation in the time before 1234.²⁵

Floor 3 is marked by a sand layer up to 20 cm thick. In this the remains of an otherwise removed cobblestone covering were found. The youngest registered floor of

the cellar, Floor 4, was represented by a 6- to 10-cm-thick heterogeneous/stirred-up marine clay layer, above which a decomposition layer was found. In the marine clay layer, a

coin minted in Ribe during King Abel's brief reign in 1250–52 was found.²⁶ (Figure 16, digitalized profile w. floor layer)

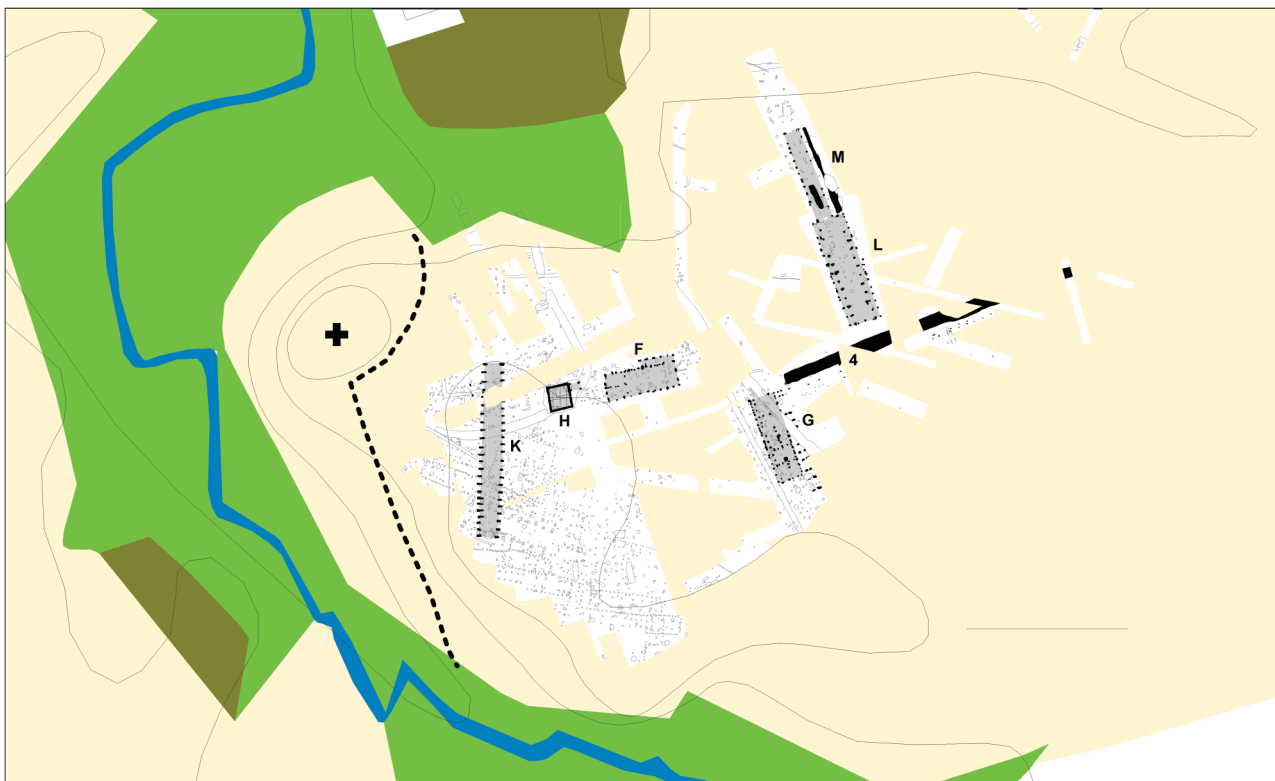
Figure 17. Phase 4. Second quarter of the 1200s. The complex is expanded with animal shed and barn buildings as well as the poker-straight Ditch 4.

Building K measured 54 m in length, and its width can be estimated as 6.2 m, resulting in a ground area of 335 m². The building consisted of two parallel rows of posts that did not stand in pairs. There were no traces of openings in the walls, interior divisions or fixtures. At the south gable, a 1-m deep medieval pit was found; its placing does not preclude the possibility that it was dug while the building was standing, but its function could not

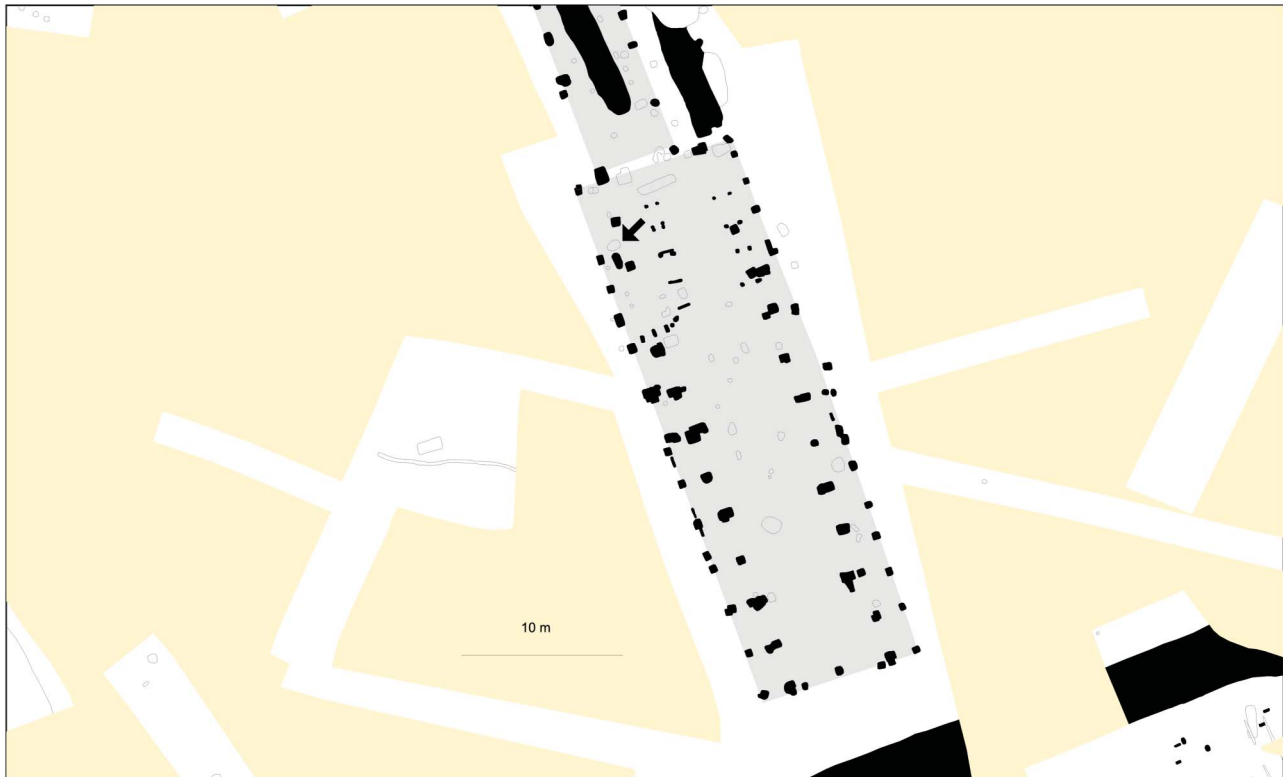
Figure 18. The three-winged barn or animal shed, Building L, was laid out with great precision. The roof-bearing posts formed pairs, and by all indications this was a head construction. At the north end of the west side wing of the building, there were stall-like structures and the arrow marks the position of a buried cow skull – perhaps a disease-averting construction sacrifice.

By virtue of its great width and accurate post positioning Building L was the most impressive house site of the excavations (Figure 18). The N–S-oriented building measured 33.7×10.1 m and covered a ground area of 339 m^2 – the same area as Building K occupied. Building L's ground plan was three-winged, and the roof-bearing posts formed sets across the building throughout its length. Towards the north, however, one post was missing in the western and eastern row, respectively; perhaps they had not been dug as deeply as the others. The span between the roof-bearing posts was 6.7 m and the distance between bays was 2.8 m. The building was equipped with a 1.7-m wide projection along both walls throughout its length. The orientation is exactly parallel to that of Building G – a

In its posts and dimensions, Building L recalls the oldest preserved manorial barns.³² The preserved examples are head constructions on foundation stones, but may have had predecessors with dug-down posts. The absence of finds in the post-holes as well as the possible stall partitions and the buried cow skull also suggest that the building was used as a barn and/or animal shed.

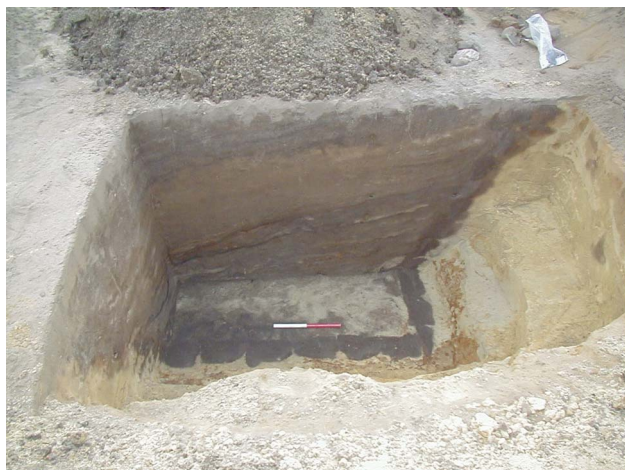
Figure 19. The sides of Ditch 4 were shored up with turf. Here we see the carefully executed western termination.

Between Buildings G and K, a large, very straight ditch was found, Ditch 4, which projected 4 m from the north east corner of Building G and from there ran eastward in a

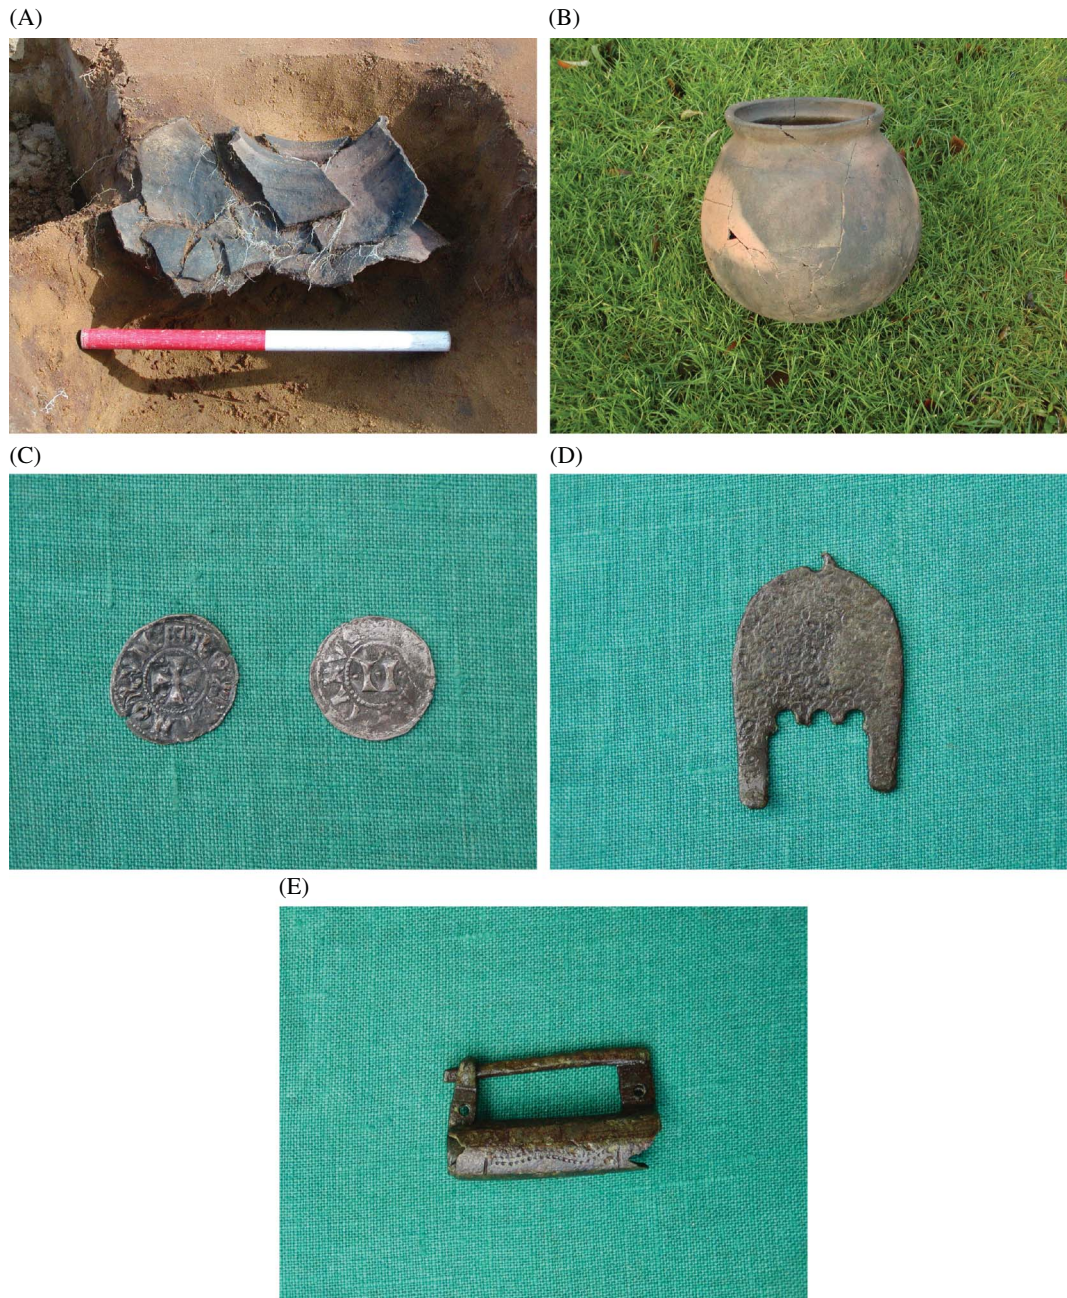
Figure 22. Finds from the excavations. In the pit A355, the heap of sherds shown here appeared, and could be assembled into a more or less intact, 27 cm tall globular pot. In the fill of the pit the two coins shown were also found; they circulated in the period 1234–55. Could this be a recovered coin hoard buried during the hostilities in 1247? Detector scanning in the early 1990s uncovered a fragment of the yoke of a set of scales with surface-covering ornamentation of circular dots as well as the intact cast casket lock with an octagonal lock housing. On three sides it is decorated with a punched, wavy line.

Beneath the plank road east of Building G, a small pit was found containing two coins minted in the reign of Valdemar II as well as 48 potsherds laid together at the bottom of the hole. The sherds could be assembled into a globular pot which when intact was only a little smaller than the pit itself (Figure 22). The unusual find combination can be interpreted as an already dug-up coin hoard.³⁵ Duke Abel's capture of Ribe on 28 April 1247 may have been the background for the burial of the hoard, but King Erik Plovpenning's recapture of the city on 3 June may be the reason why most of it came into the possession of the owner again.³⁶
