# Margrethehåb

## A Settlement Site of the Early Middle Ages at Roskilde, Zealand

by TOM CHRISTENSEN

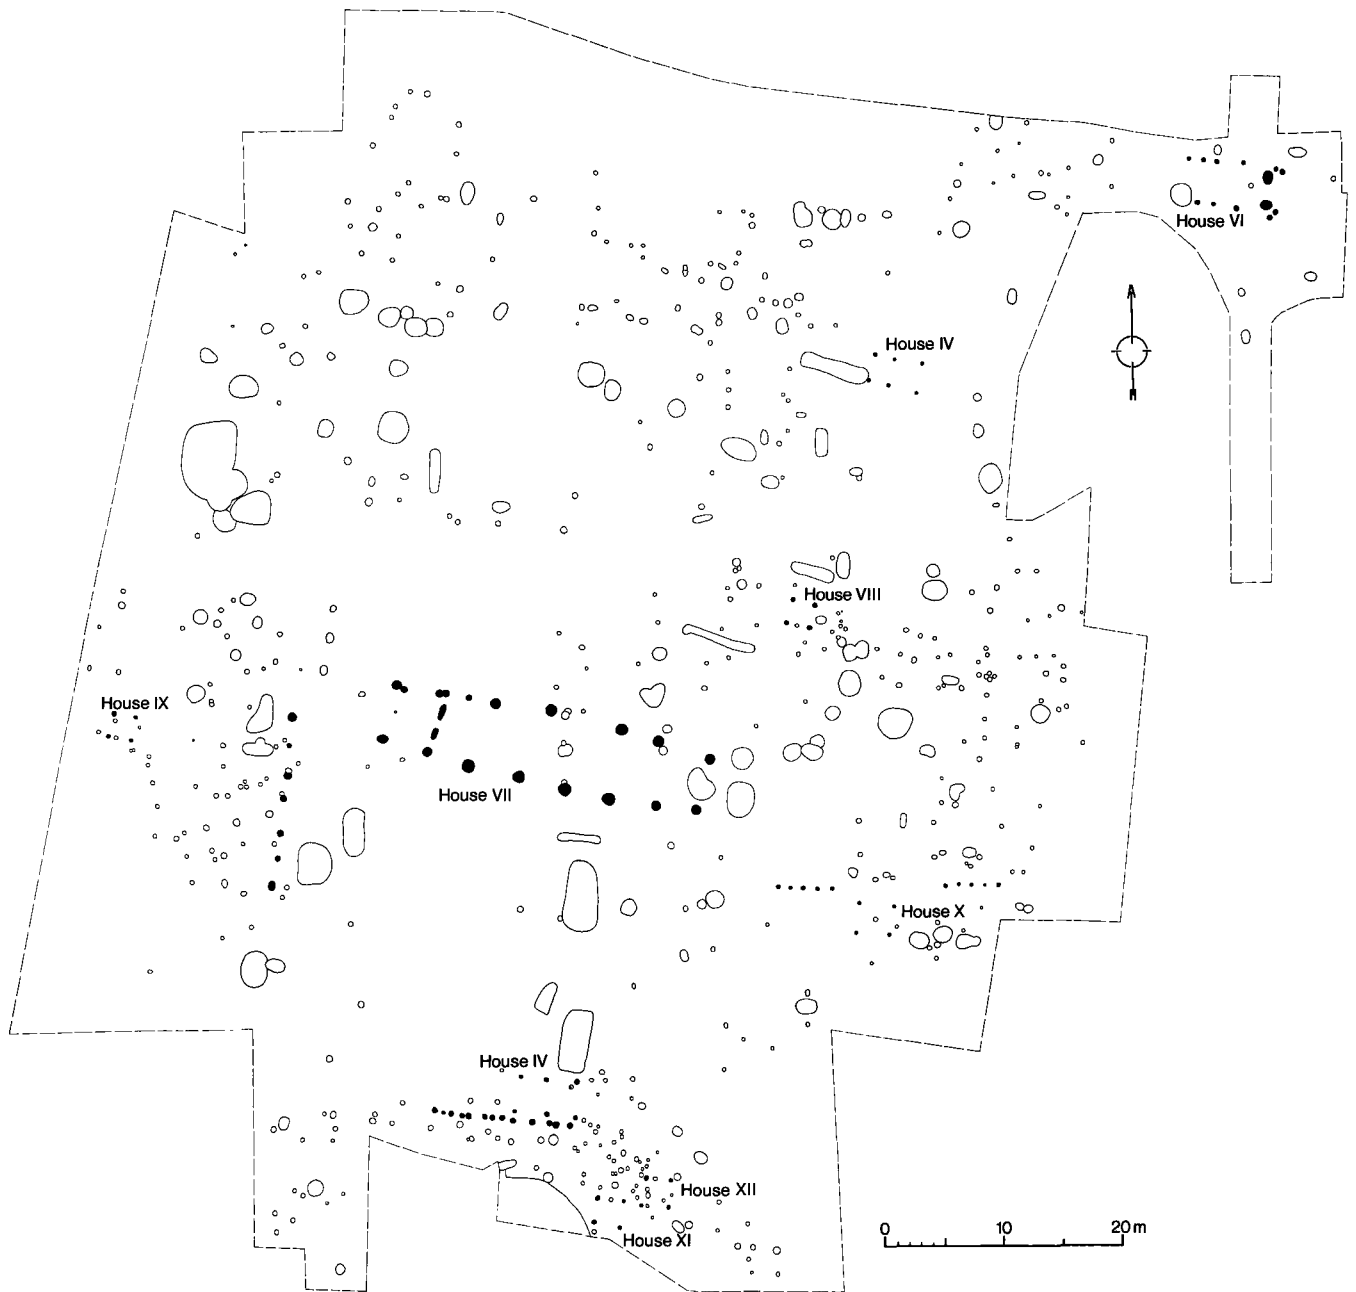
Fig. 5. Plan of Margrethehåb II, showing the medieval farm.

On a clear bank about 100 m. west of Site I and separated from it by a minor watercourse lay Site II (Fig. 5). In the area of about 10,000 sq.m. excavated a few neolithic and early Iron-age pits appeared, but the majority of the structures, including all the buildings and fences, could be dated to the 11th and 12th centuries.

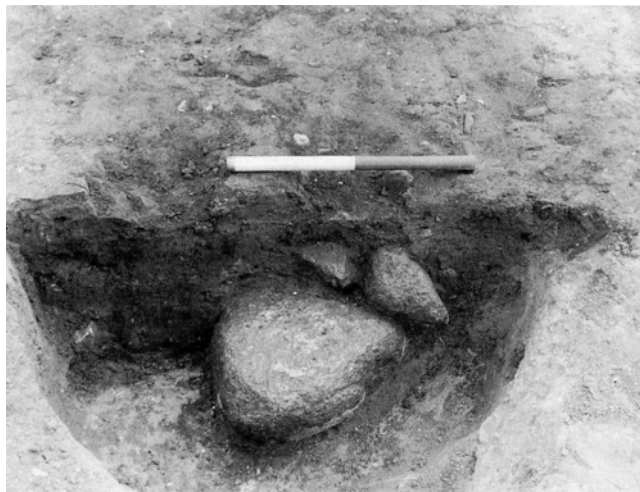
Fig. 8. Wall post with boulder from house VII.

which were of very varied depths, a sill-like construction was used where large stones were placed as packing for the posts. One was placed above a flat boulder (Fig. 8).
