Proceedings of the Danish Institute at Athens V

The Zea shipsheds – new remarks on a tile deposit and other related finds

Mette K. Schaldemose

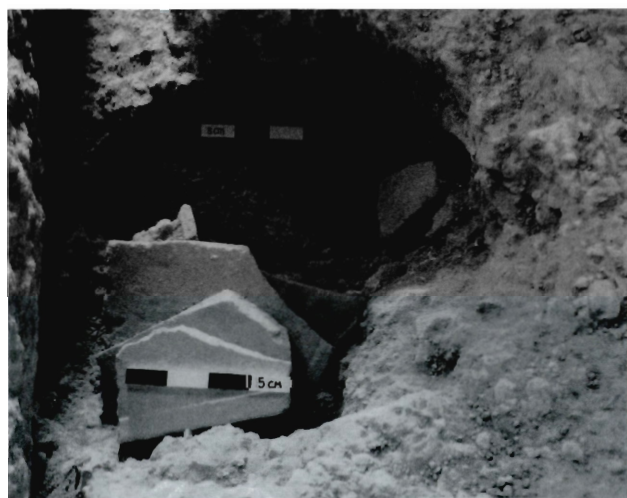
Fig. 28. Area 1, Shipshed 16, feature S17:U1 (Christensen 2002).

During the land excavation of Shipshed 17 a rock-cut pit (S17:U1) was found just north of ramp block (S17:R11)⁴ in the southern part of Shipshed 17's frame-constructed ramp (Fig. 3). The feature is preserved well below the top surface of the ramp and is not structurally related to any identified shipshed remains. Inside the pit (Fig. 28) were found four large tile fragments (1–3, Fig. 29 (1)) intentionally stacked on top of each other, and some smaller tile fragments. In the top fill of the pit were found a rim fragment of a black-glazed kantharos (14, Fig. 30) and, at the bottom of the pit, an undiagnostic black-glazed kantharos fragment with incised graffito (15, Fig. 31). West of the pit in the fill of the north side of the foundation cutting of ramp block (S17:R11), and probably unrelated to the pit itself, was found a base fragment of a black-glazed fish-plate (13, Fig. 32)
