'The coldest case of all' – fire investigation at the Viking Age ring fortress of Borgring, Denmark

Eva Ljungkvist¹, Benny Thomsen¹, Søren Michael Sindbæk^{2,4}, Jonas Christensen³, Nanna Holm³, Maja Kildetoft Schultz³, Jens Ulriksen³

ABSTRACT

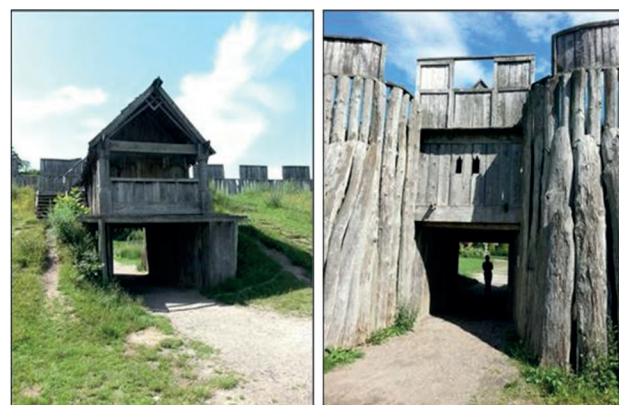
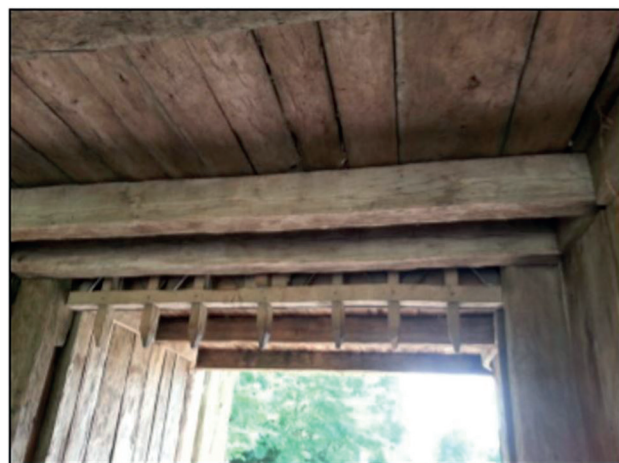
At a modern fire site, investigators typically have a full knowledge of the constructions and their properties and dynamics. In an archaeological site, these factors are often subject to uncertain reconstructions. A reconstruction of a Viking Age fortress at Trelleborg, Sweden (Figure 6), gives an esti-

Figure 6. References for fire investigation. Gateway of reconstructed fortress at Trelleborg, Sweden. a) view from inside (left) and outside (right) the gateway; b) roof cover from inside the gateway (Photos: NKC Photo).
