Geomorphological effects of the Rømø Dam: development of a tidal channel and collapse of a dike

Margot Jespersen and Erik Rasmussen

Jespersen, Margot and Rasmussen, Erik: Geomorphological effects of the Rømø Dam: development of a tidal channel and collapse of a dike. *Geografisk Tidsskrift* 84: 17-24. Copenhagen, January 1984.

The Rømø Dam has had positive, but also negative effects on the surrounding wadden sea area. This paper describes the negative influence of the dam on the east coast of Rømø. Registrations have been carried out since 1951.

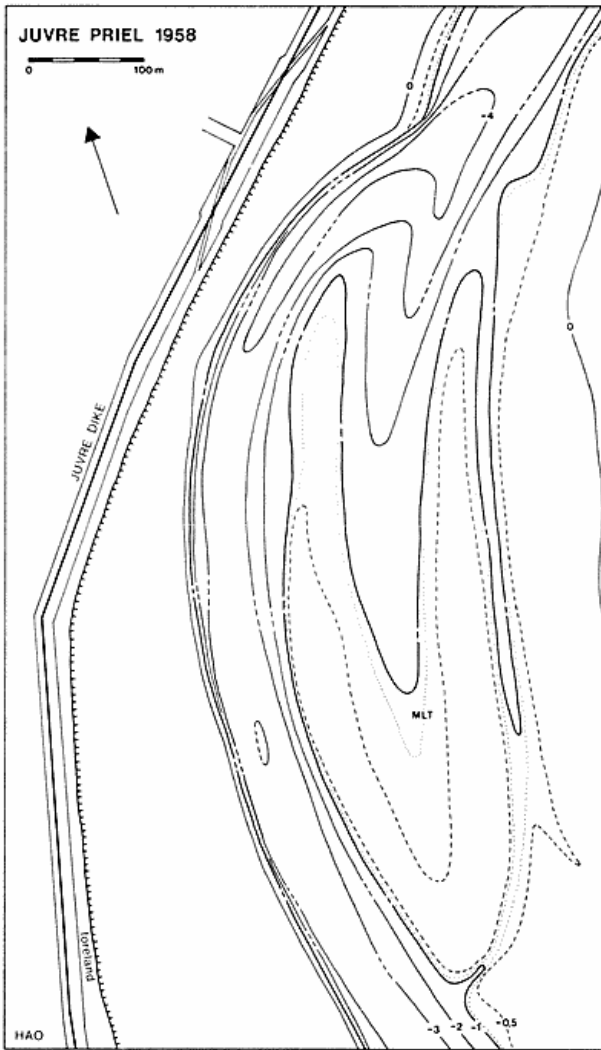
Fig. 6. Contour map from 1958.
Fig. 6. Højdekort fra 1958.

The development from 1955 to 1982 is shown on the contour maps, Figs 5-8. At the beginning of the period, from 1955 to 1958, the migration speed of the meander curve was decreasing; the total loss in area was only 2.8 ha, or approximately 0.9 ha per year. In 1958, the western bank of the ebb channel was located roughly 50 m from the dike; this means the same displacement in three years as previously in one year. The direction of migration was still northwesterly, i.e. almost at right angles to the dike. In the following years the landward migration of the meander continued. By 1963, the ebb channel had eroded its way up to the foreland, by 1967 up to the base of the dike, and in 1974 it had reached the core of the dike. From 1958 to 1974 the total loss of area amounted to 5.2 ha. For the periods 1958-63, 1963-67, and 1967-74 the average annual losses have been calculated to be 0.5 ha, 0.3 ha, and 0.2 ha respectively. This clearly shows that the

moreover in 1958 had reached a greater height than the westernmost in contrast to what was the case in 1955. This change initiates a new phase in the development of the flood bar. Again it became irregular, but now due to a vigorous development of the easternmost branch both with regard to area as well as height. During this phase the flood bar achieved a height above DNN for the first time. In 1974, an area of 0.2 ha could be observed above this level and, in 1982, it had increased to 3.3 ha. Up to 1958, the area of the flood channel increased along with the formation of the flood bar (Figs 4-6). As with the flood bar, there was likewise a fundamental change in the development of the flood channel from 1958. From this year on the flood channel was being filled up to a great extent. Thus areas with depths below -1 m were about 5 times the size in 1958 as compared with 1982, and in 1958 depths below -2 m could be observed, a value which does

not occur in 1982 (Table 1). As mentioned above, the eastern border of the flood bar was a channel which, in 1958, still connected the northern and the southern part of the ebb channel in that along its whole length, it had depths below low-tide level. After 1958 the channel filled up resulting in a break in the connection to the southern part of the ebb channel. In 1974, the channel had been reduced to a tidal creek with outlet into the northern part of the ebb channel. In 1982 there was an apparent tendency towards a new increase in size of the creek.

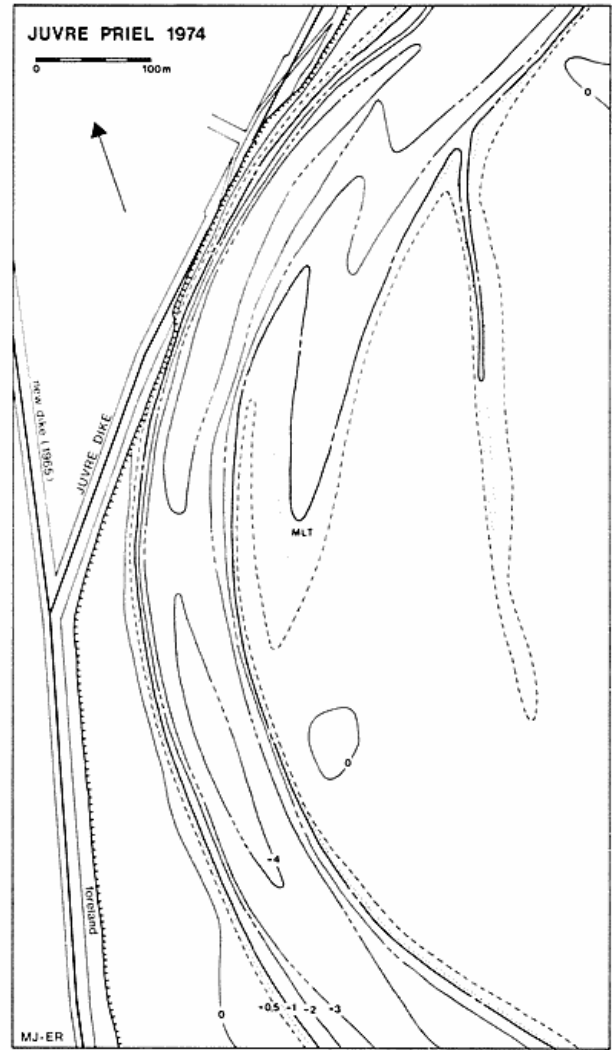
Fig. 7. Contour map from 1974.
Fig. 7. Højdekort fra 1974.

Siden 1951 har man forsøgt at standse prielens vandring mod diget bl.a. ved sprængning af nye afløbsrender (fig. 11). Alle forsøg var forgæves, og i 1965 byggedes et tilbagetrukket dige (fig. 3). Allerede i 1974 var 150 m af digekernen blottaget (fig. 7). Ved stormfloden 1981 blev digekronen gennembrudt, og området mellem de to diger overskyldet. Den indespærrede vandmasse fik afløb ved at gennembryde diget indefra (fig. 12) under dannelse af et halvcirkelformet hul i marsken (fig. 13). I 1982 blev prielens vandring forsøgt standset ved opfyldning og anlæggelse af et kraftigt glacis (fig. 8). De videre undersøgelser af Juvrepriens morfologiske udvikling vil primært være centreret om effekten af dette indgreb.

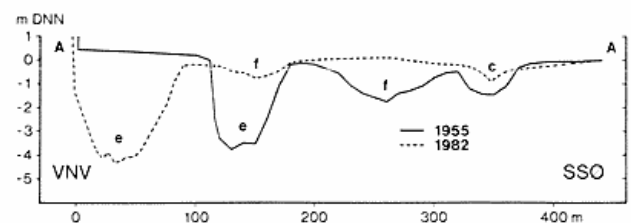
In the following, the development of the Juvre Priel from 1955 to 1982 (cf. Fig. 9) is summed up. The ebb channel has been displaced - at decreasing speed - in a northwestern direction, simultaneously becoming both deeper and wider. Likewise, the flood channel has been displaced toward the northwest along with the dislocation of the ebb channel. At the same time the size of the flood channel is diminishing. The flood bar is growing both in area and in height. It is asymmetrical both in 1955 and in 1982, but has changed fundamentally in shape during this period. In 1955 the western branch is the most developed in contrast to 1982 when the eastern branch is the dominating one. The channel along the eastern bank of the flood bar has been stationary during the whole period and represents thus still in 1982 the original eastern bank of the Juvre Priel (Fig. 4). Sedimentation has blocked the connection to the southern part of the ebb channel, however. The development recorded of the Juvre Priel regarding the displacement of the ebb channel, the growth of the flood bar and its changing asymmetry as well as the filling up of the flood channel are all in accordance with the theories advanced by Børge Jakobsen on the morphologi-

Fig. 9. Cross profile of the Juvre Priel (A-A Figs. 5 and 8). e. ebb channel. f. flood channel. c. tidal creek.
