## Medieval church roof constructions in North Schleswig and Southwestern Jutland – examples of tradition and innovation

Only few of the Danish medieval parish churches can be dated. This paper presents an attempt of doing so by the help of dendrochronology of a number of church roofs of different types. Results show this is possible although only in cases where original roofs are preserved in a sufficient degree. The typology of church roof constructions has been revisited and so has the general dating of types and their origins.

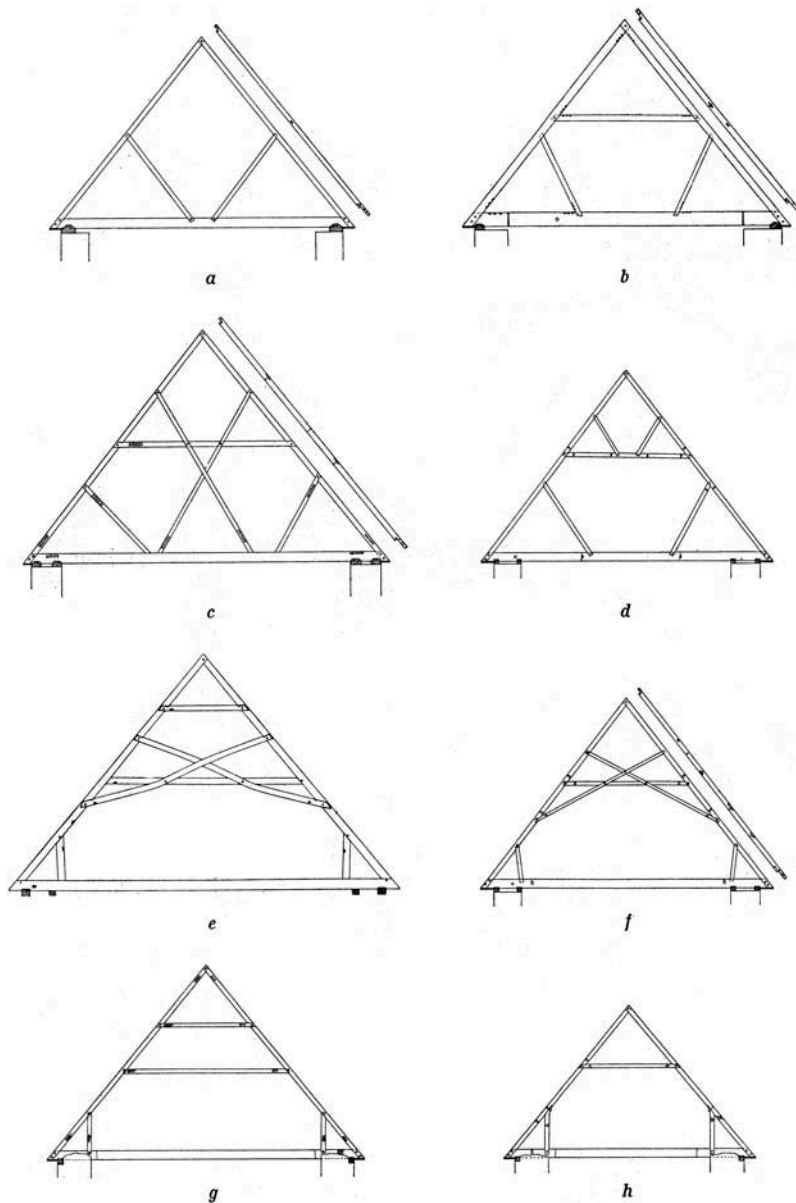
Figure 3. Elna Møller's classification of truss types from her paper in 1953. After Møller (1953).

the case with the church in Arrild some 15 kilometres south east of Ribe (Figures 4 and 7) (Danmarks Kirker 1953, p. 1264, cf. Danmarks Kirker 1963, p. 2700).<sup>3</sup> Elna Møller once called the truss type in the nave, with its two pairs of long struts, the Arrild type (cf. Figures 3c and 8). At the same time she considered this and a related type called after Arrild's neighbouring church Roager to be the oldest truss types exhibited by the churches of the area. However, it has been established that the timber in the roof structure of the nave of Arrild was felled in 1354 – but it should be noted that this was a renovated roof, which had replaced the original one of the same type after a fire. The Roager type too has turned out to have a considerably longer history than was thought, so we must assume that these types represent longer-standing regional features rather than chronological features alone and that they should not be considered as chronologically significant for any larger regions.
